Klipspruit Colliery

Structural Assessment of CV06 N12 BRIDGE

Report Date: 08 August 2025

Klipspruit Colliery- Structural Assessment of CV06 N12 Bridge

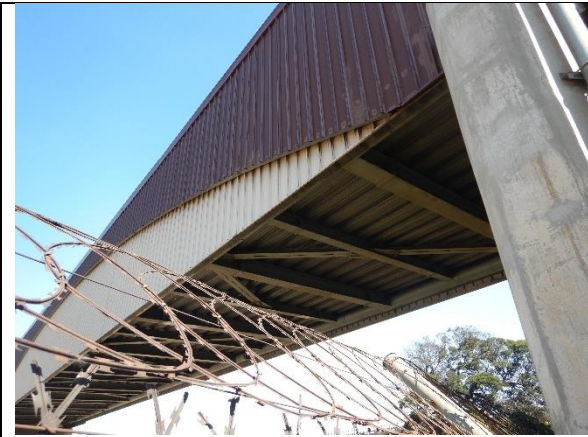
Fig. 3.1: Exterior envelope of the walkway

The exterior cladding panels sheeting remains free from damage and corrosion.

Condition Category:	2	Priority:	3
Recommendation:		Risk Rating:	9

Regular inspection of the cladding panels is recommended to allow for the early identification of any potential damage.

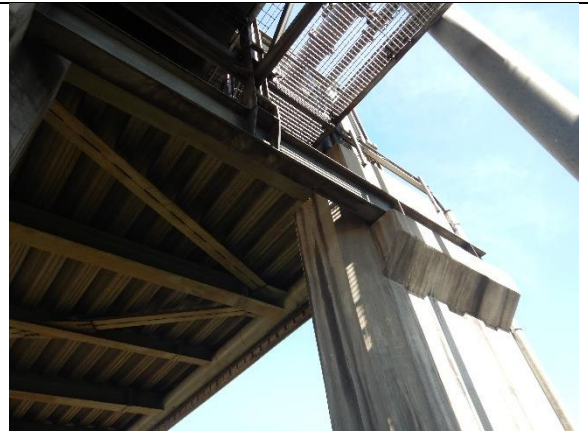
Fig.3.2: Steel floor beam girders

The steel floor beam supporting the bridge deck is structurally sound, exhibiting no visible signs of distress, such as deformation, overstressing, or localized damage.

Condition Category:	2	Priority:	3
Recommendation:		Risk Rating:	9

Continue monitoring the beam girder's condition through scheduled inspections to ensure early detection of any deterioration.

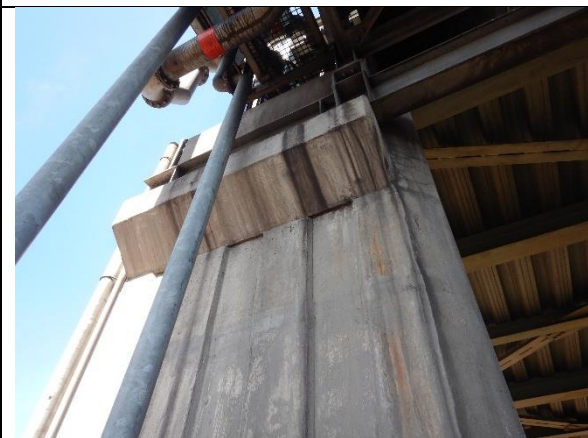
Fig.3.3: Pier head/cap

The pier cap, functioning as the load transfer interface between the superstructure and substructure by distributing reactions from the bridge beams, is in satisfactory structural condition with no visible indications of material degradation, cracking, or distress.

Condition Category:	2	Priority:	3
Recommendation:		Risk Rating:	9

Maintain periodic visual inspections of the pier cap to monitor for any early signs of structural distress, such as cracking, spalling, or settlement.

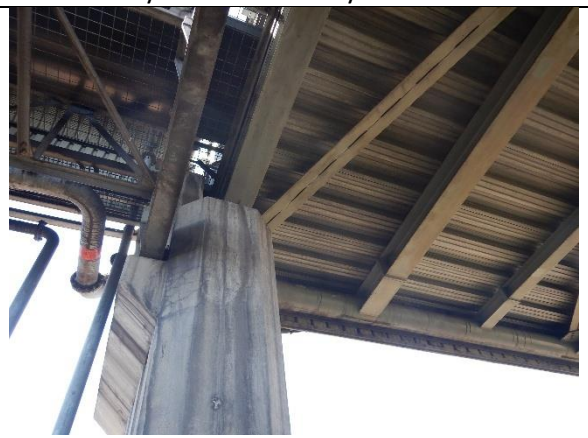
Fig. 3.4: Pier cap

The pier cap, acting as a bearing area to support the bridge beams and distribute load evenly, remains in good condition with no sign of deterioration or damage observed.

Condition Category:	2	Priority:	3
Recommendation:		Risk Rating:	9

Maintain periodic visual inspections of the pier cap to monitor for any early signs of structural distress, such as cracking, spalling, or settlement.

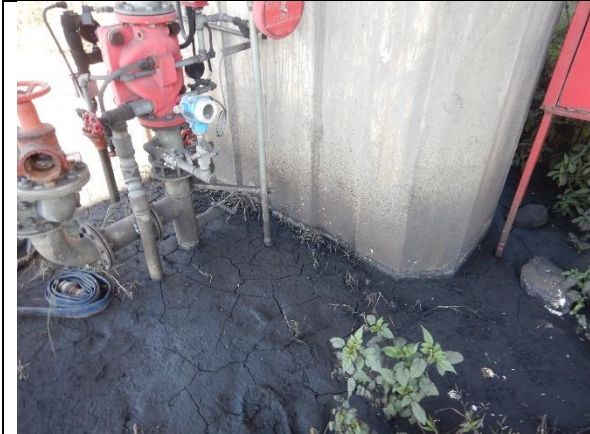
Fig.3.9: Base of the concrete pier

The base of the concrete pier is structurally sound, showing no evidence of surface wear, cracking, spalling, or other forms of concrete deterioration. No signs of differential settlement were observed.

Condition Category:	2	Priority:	3
Recommendation:		Risk Rating:	9

Continue with routine inspections to ensure the base of the pier remains free from structural defects. Monitor for any future signs of distress or ground movement.

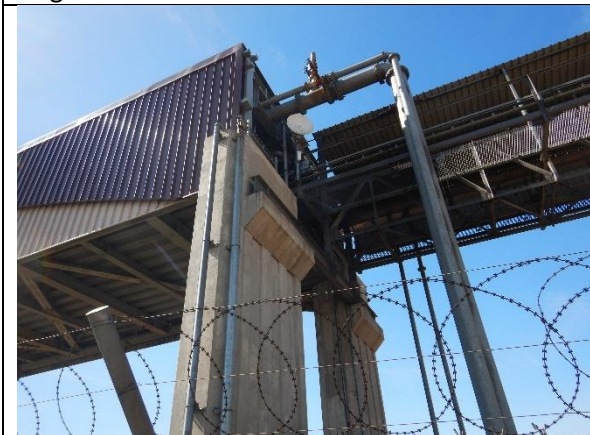
Fig.3.11: Pier heads/caps

The pier caps supporting the bridge beams remain in good condition with no sign of deterioration or damage observed.

Condition Category:	2	Priority:	3
Recommendation:		Risk Rating:	9

Maintain periodic visual inspections of the pier caps to monitor for any early signs of structural distress, such as cracking, spalling, or settlement.

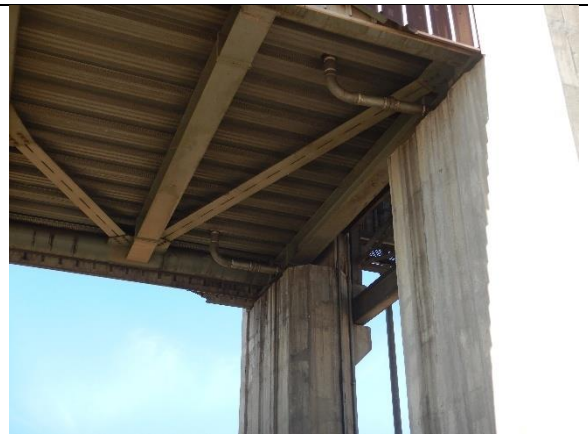
Fig. 3.12: Piers

The piers supporting the beam girders of the bridge remain in good structural condition.

Condition Category:	2	Priority:	3
Recommendation:		Risk Rating:	9

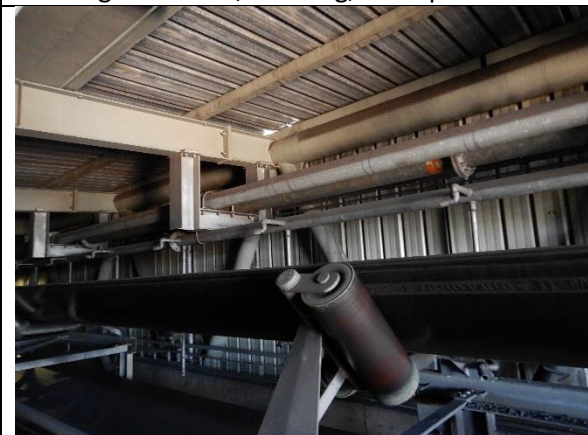
Fig. 3.19: Interior of the enclosed walkway structure

The roof steel framework is in good condition, with its structural integrity fully preserved and no observable signs of damage or degradation.

Condition Category:	2	Priority:	3
Recommendation:	Risk Rating:		9

Perform routine inspections of the structure to ensure continued structural integrity. Monitor for potential issues such as corrosion, loose connections, or deformation, particularly at joints and load-bearing points.

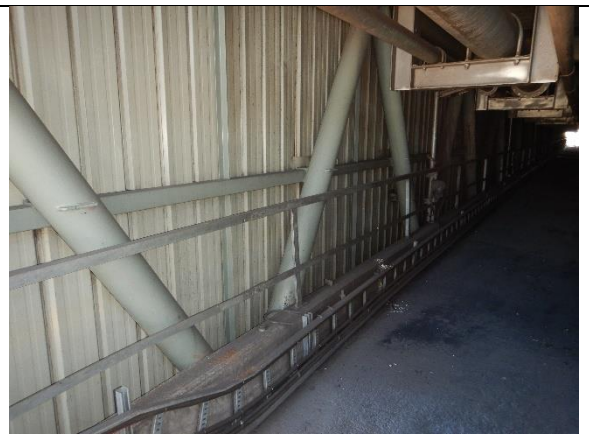
Fig. 3.20: Internal cladding sheets and side bracing assemblies

The sheeting is free from damage or corrosion. The bracing assembly remains intact.

Condition Category:	2	Priority:	3
Recommendation:	Risk Rating:		9

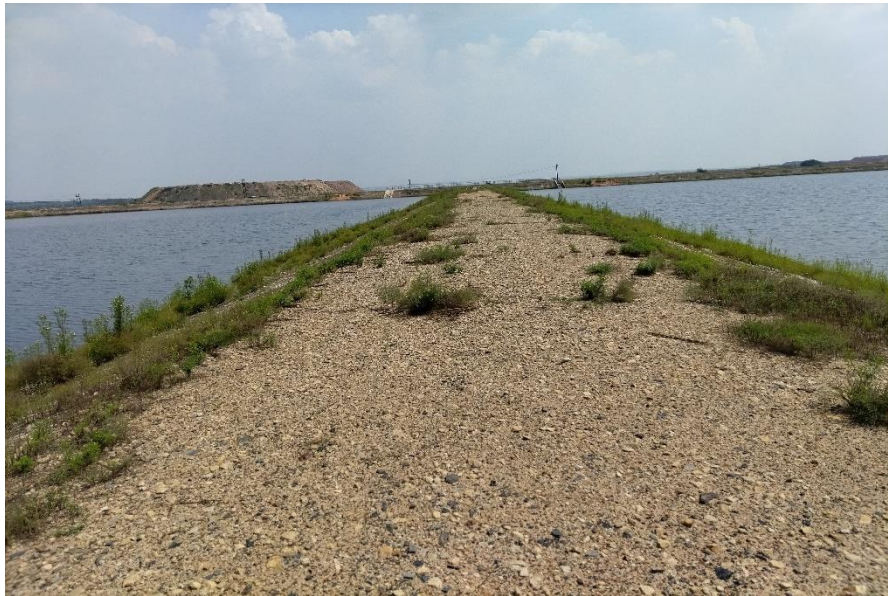
Photo 1: Wall crest condition

Unsatisfactory

An uneven walkway was observed on the crest, which needs to be levelled by adding a 150mm layer of G5 material

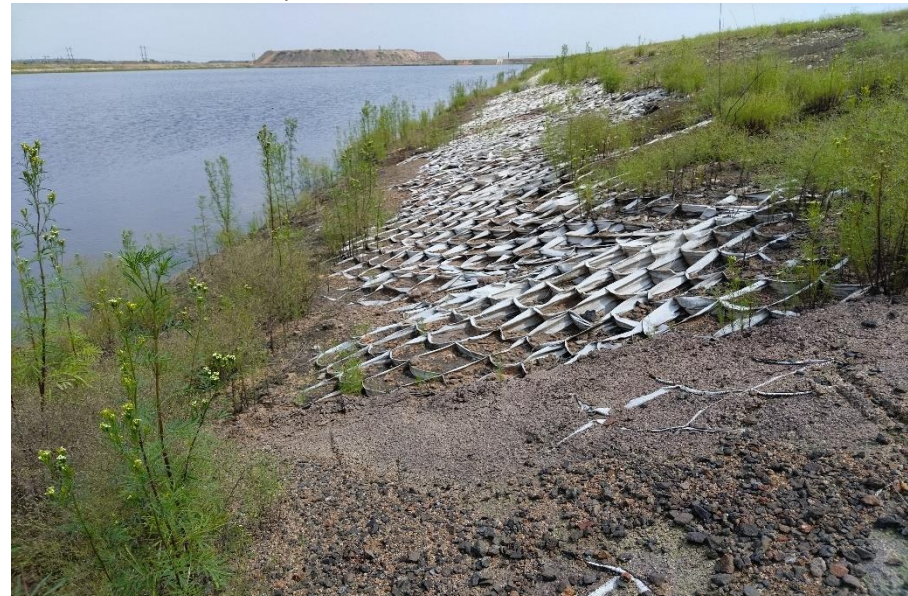
Photo 2: Wall inner slope condition

Unsatisfactory

Vegetation growth noted on the inner wall slope

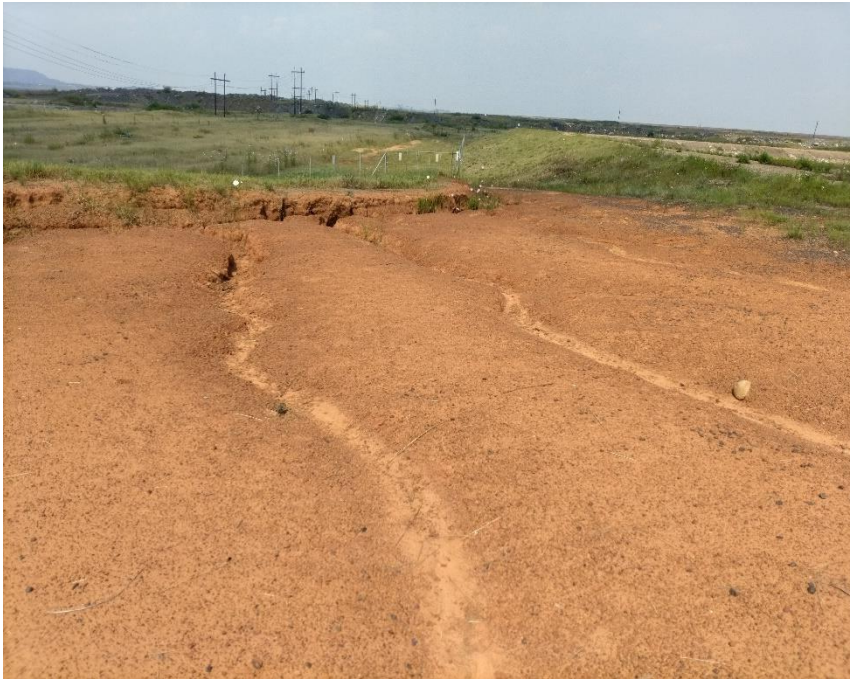
Photo 3: Erosion gullies

Unsatisfactory

Erosion gullies observed near the silt trap area

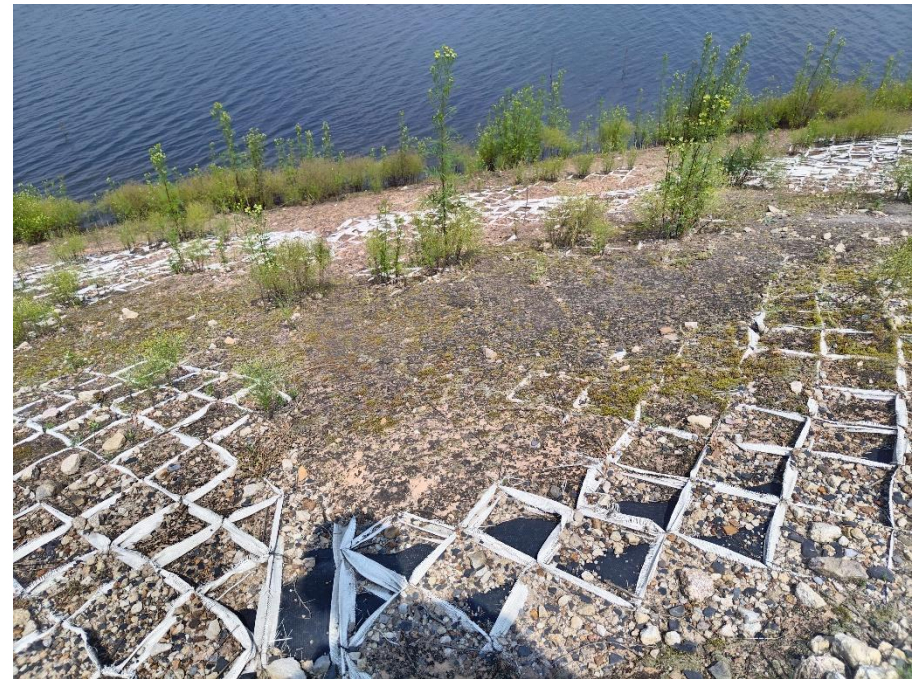
Photo 4: Vegetation

Unsatisfactory

Vegetation noted on the inside and outside wall. Additionally, sections of HDPE liner were observed

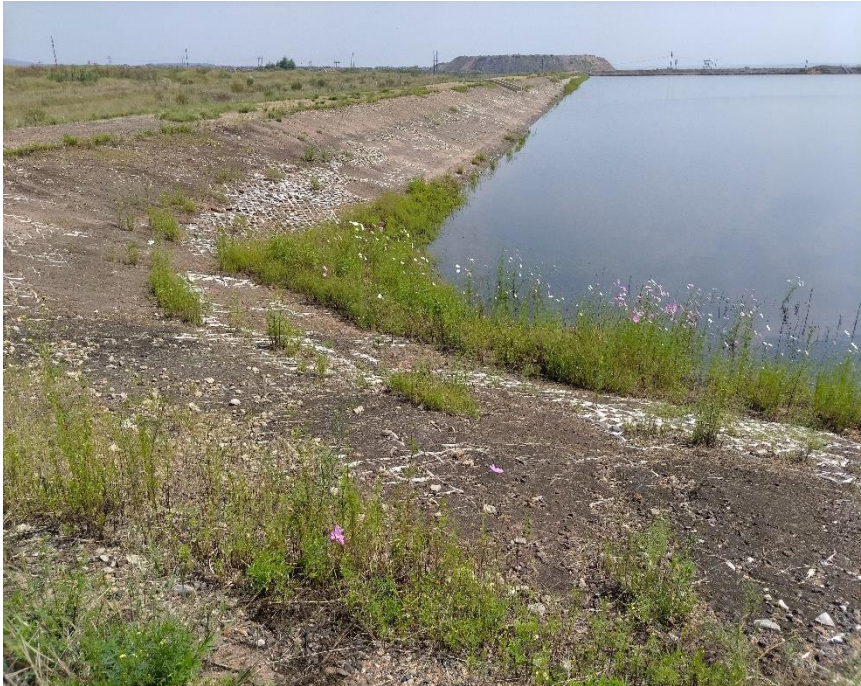
Photo 5: Dam basin

Unsatisfactory

Minor vegetation observed at the dam basin

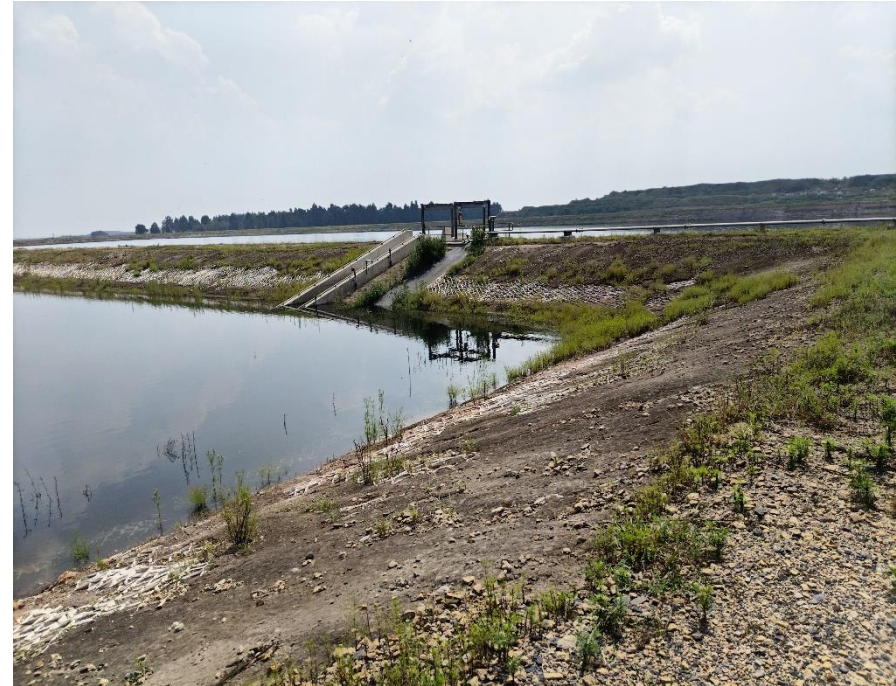
Photo 6: Dam basin

Unsatisfactory

Minor vegetation observed at the dam basin

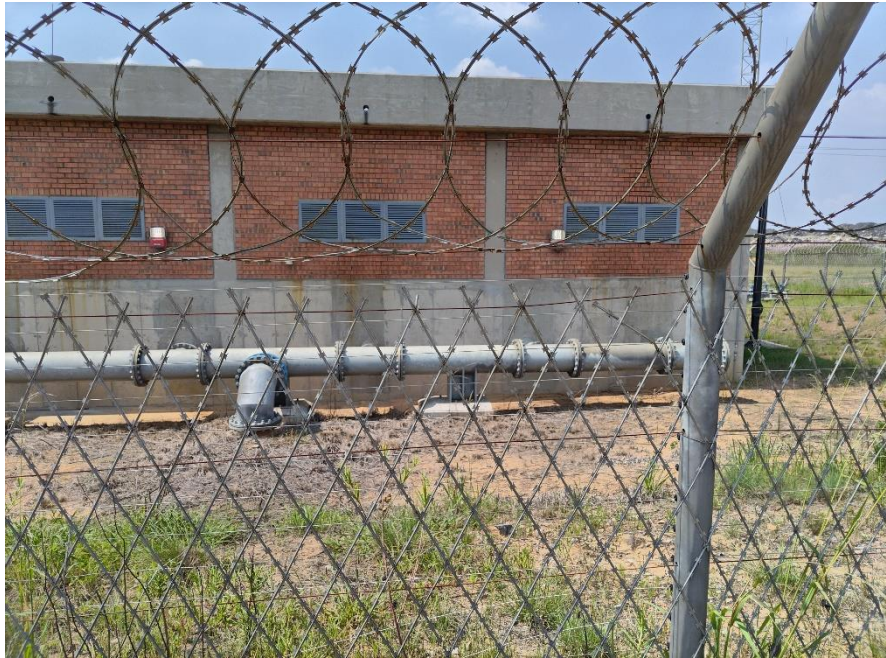
Photo 9: Pumpstation

Satisfactory
No leakages noted

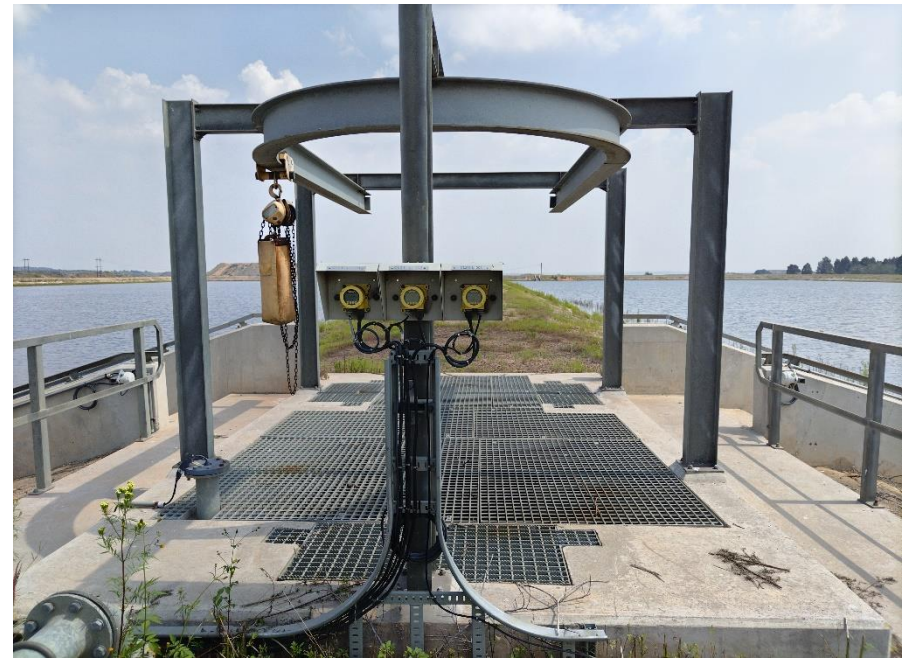
Photo 10: Outlet pipes

Satisfactory
No concerns

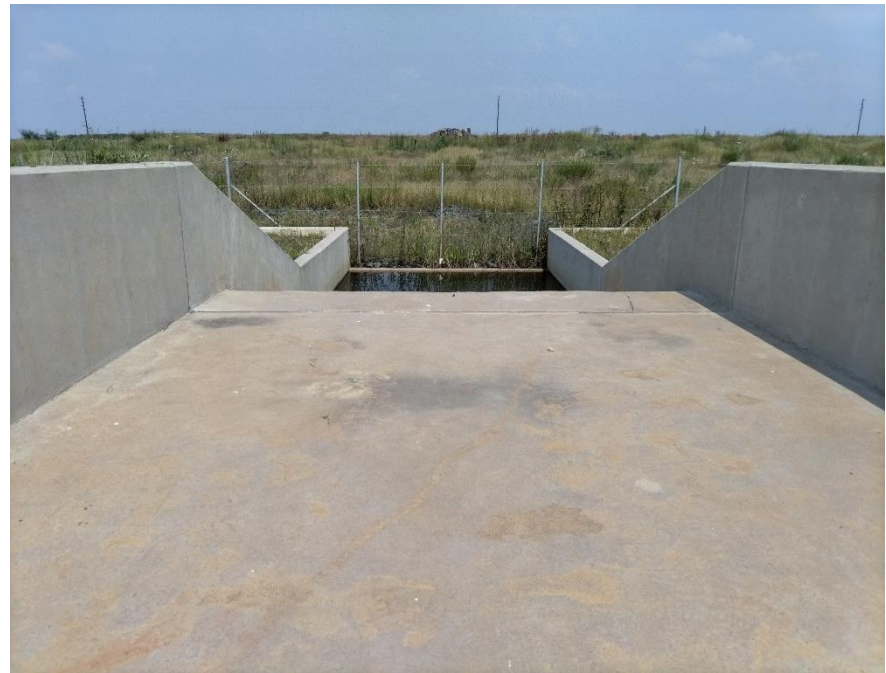
Photo 12: Outflow spillway

Satisfactory
No concerns

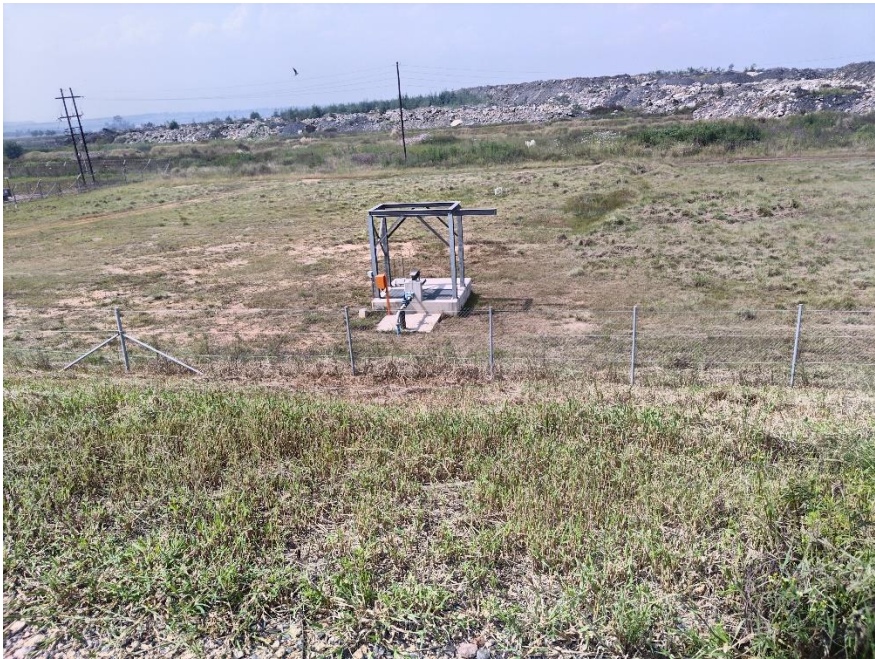
Photo 13: Leakage detectors

Satisfactory
No concerns

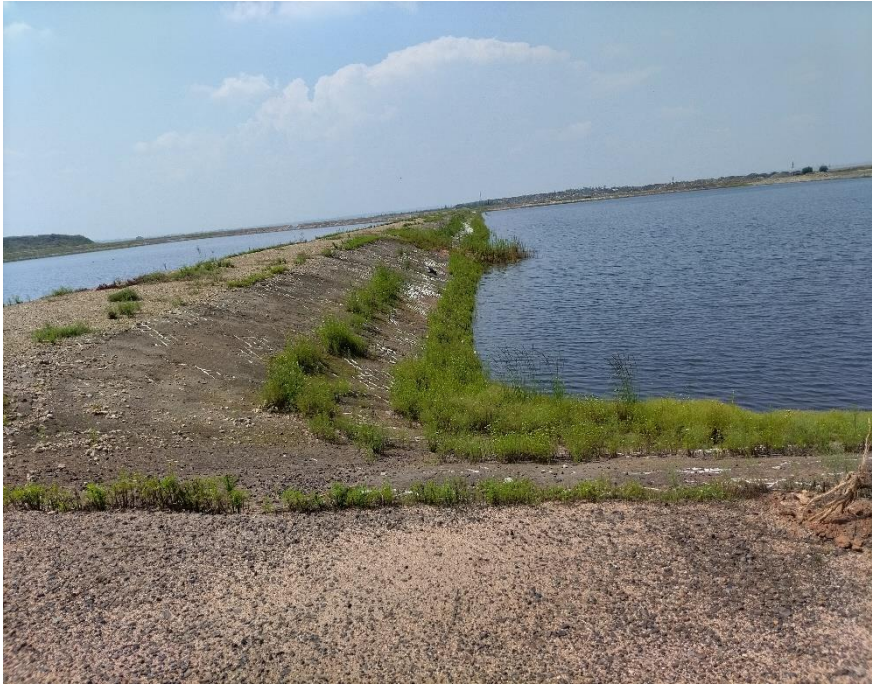
Photo 15: Safety Buoy

Unsatisfactory

No safety nets and safety bouys noted. This must be verified against the Seriti safety standard

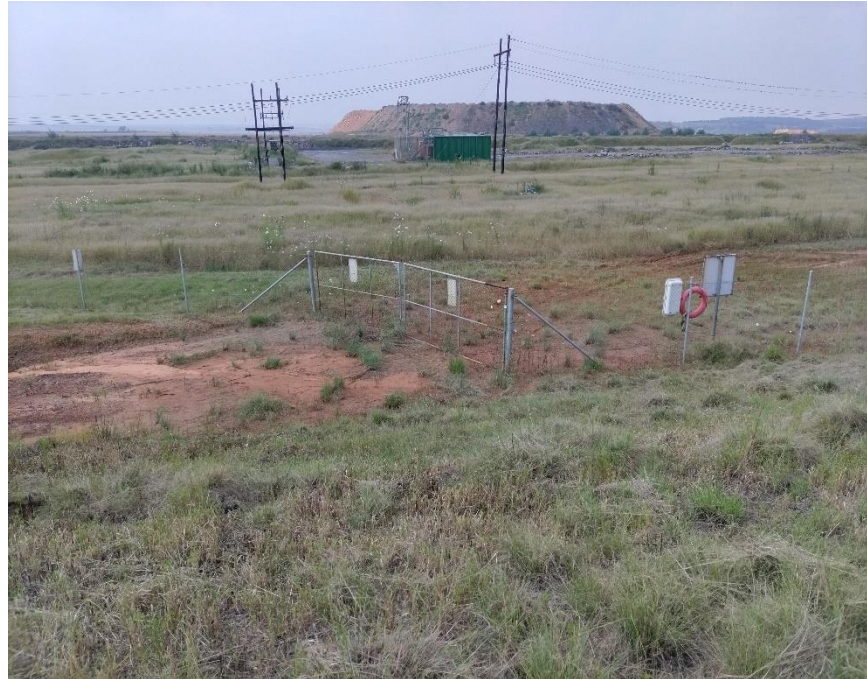
Photo 16: Safety Signage

Unsatisfactory

"No Entry" signage missing at the entrance. Adequate signage is required

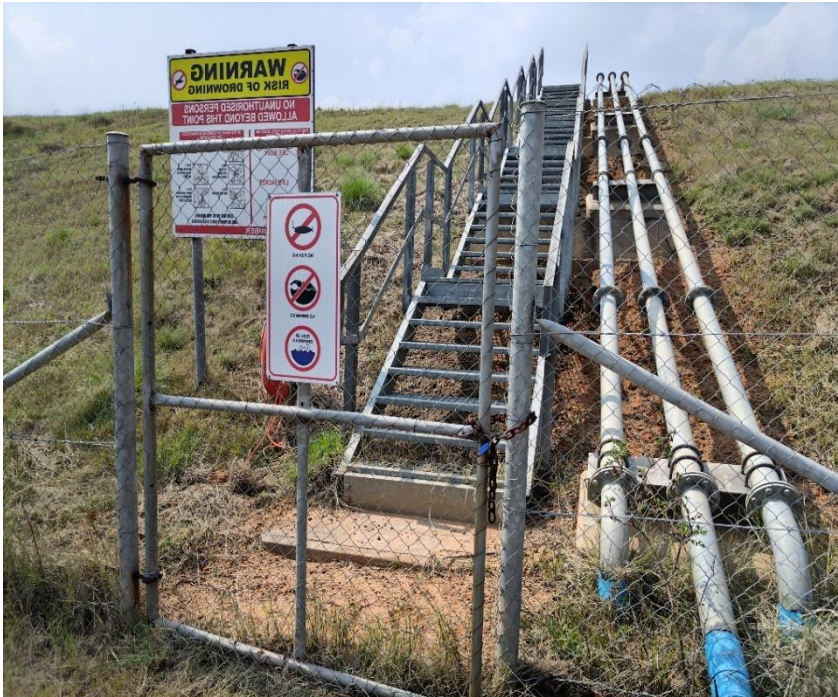
Photo 17: Fence

Satisfactory

Adequate access control was observed on-site

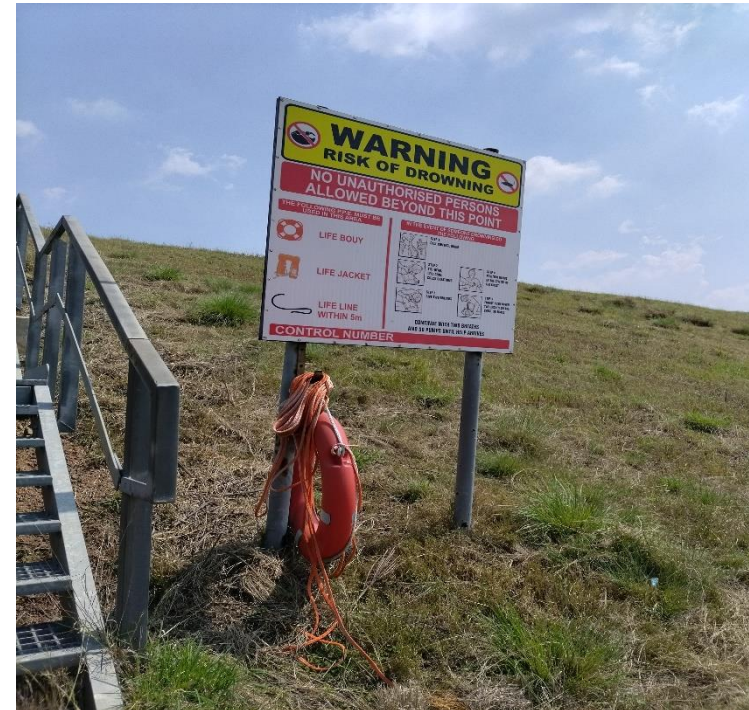
Photo 18: Safety equipment

Unsatisfactory

No emergency numbers observed at the compartment. Emergency numbers are required on the safety board. Additionally, there was no safety case observed

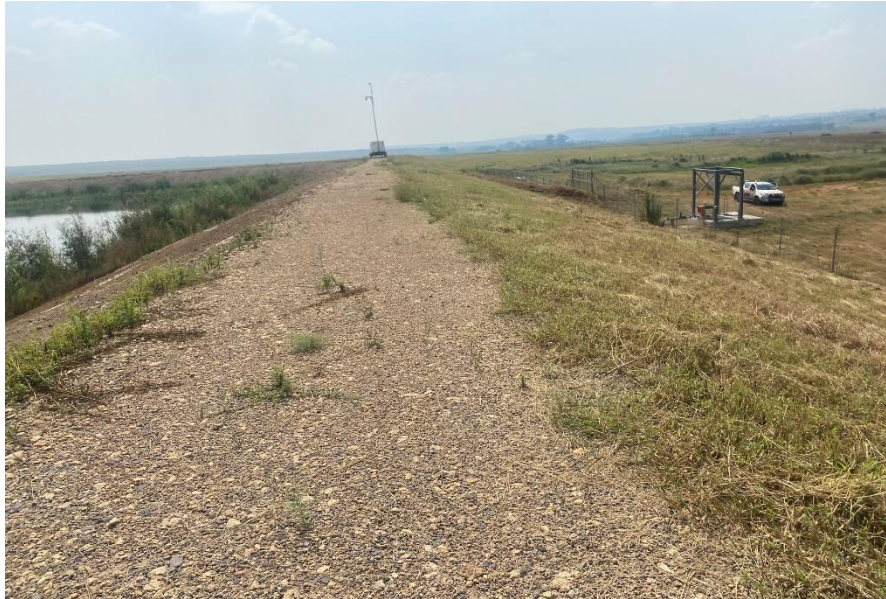
Photo 1: Wall crest condition

Satisfactory
No concerns

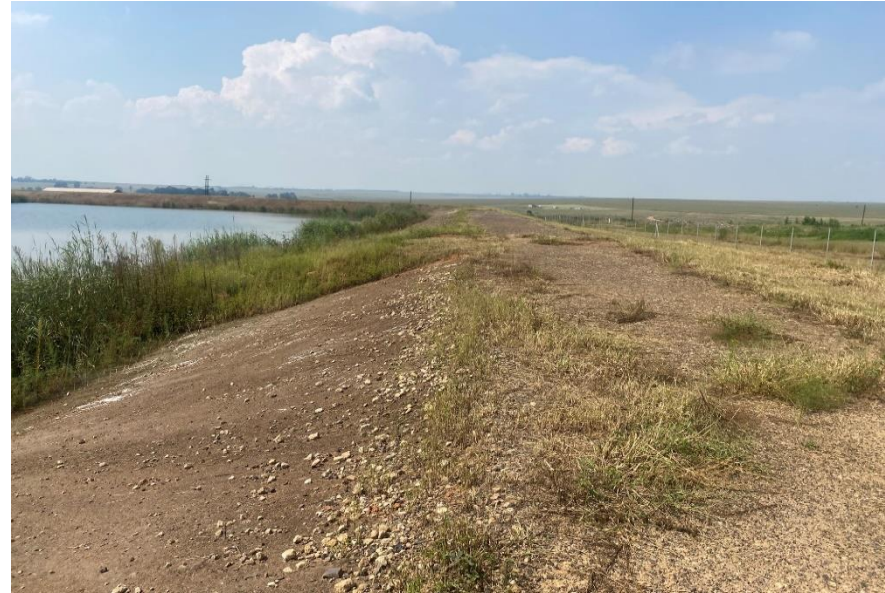
Photo 2: Wall crest condition

Unsatisfactory
Excess fill material was noted on the inner slope of the embankment wall, indicating a potential deviation from the original design shape of the compartment

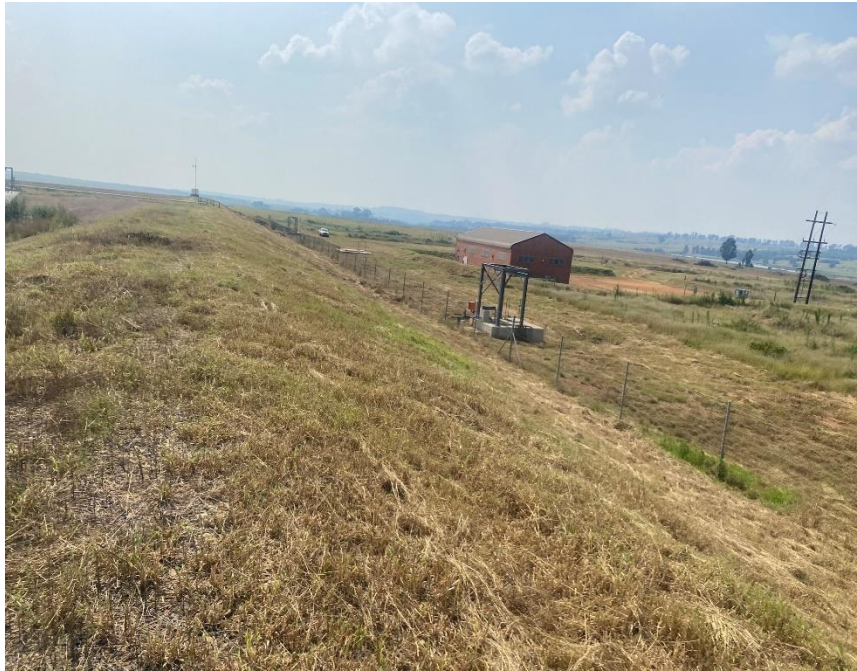
Photo 3: Grass condition

Note:
Grass-cutting were carried out at the time of inspection

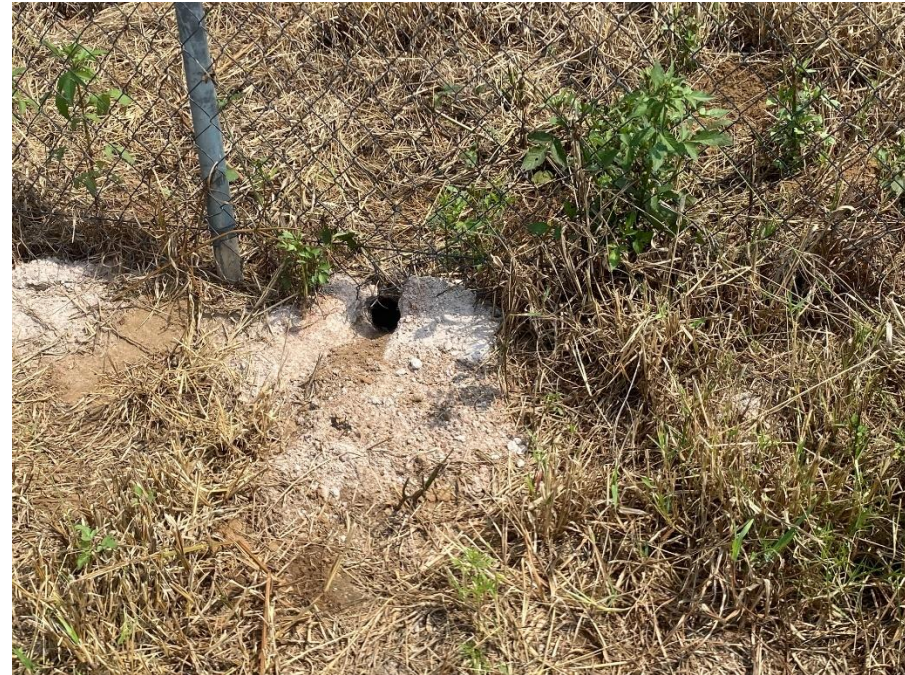
Photo 4: Holes on embankment

Unsatisfactory
Multiple holes were observed on the toe of the wall.

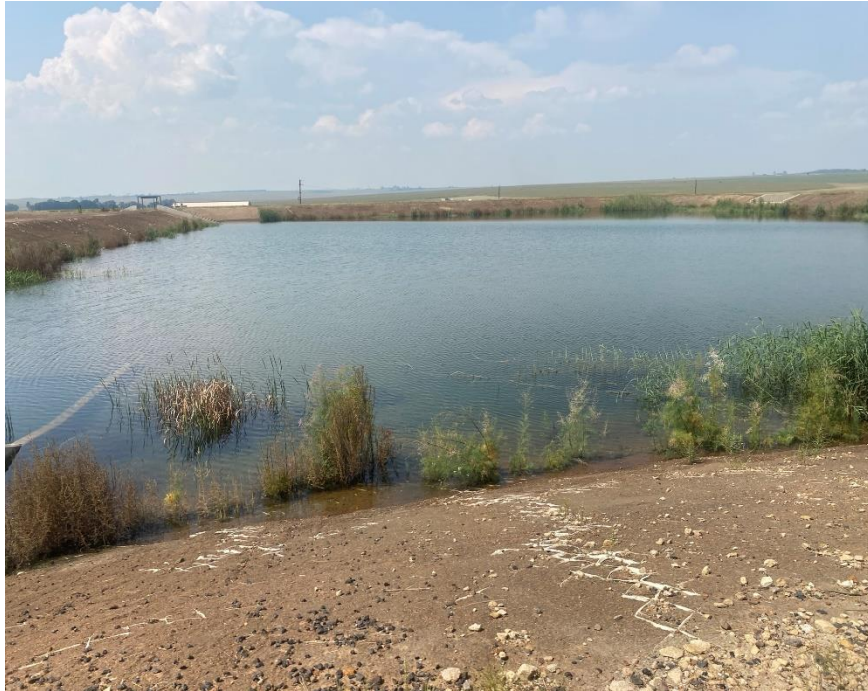
Photo 5: Dam basin

Unsatisfactory

Reeds observed growing inside the dam basin

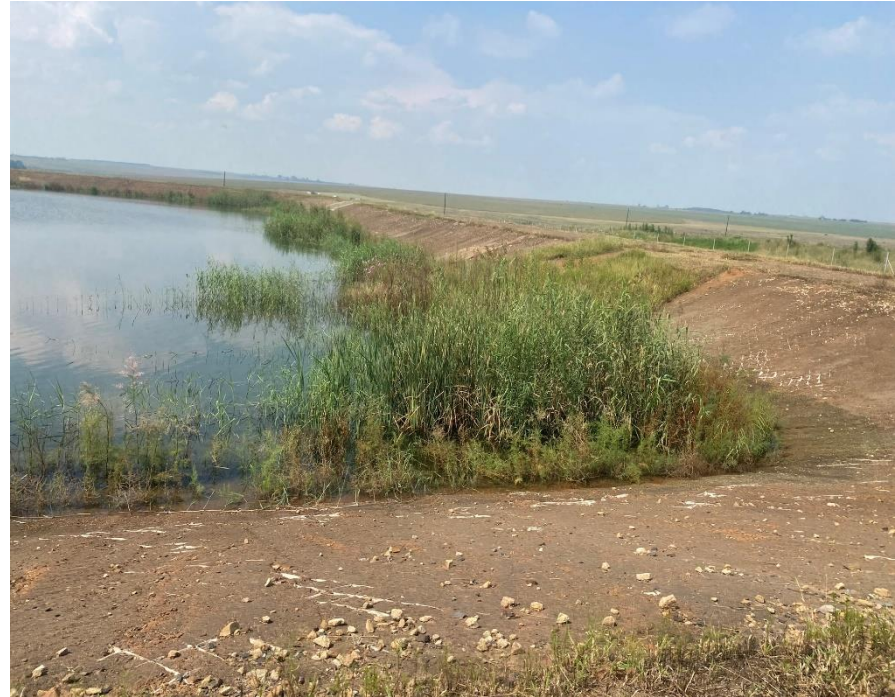
Photo 6: Dam basin

Unsatisfactory

Reeds observed growing inside the dam basin

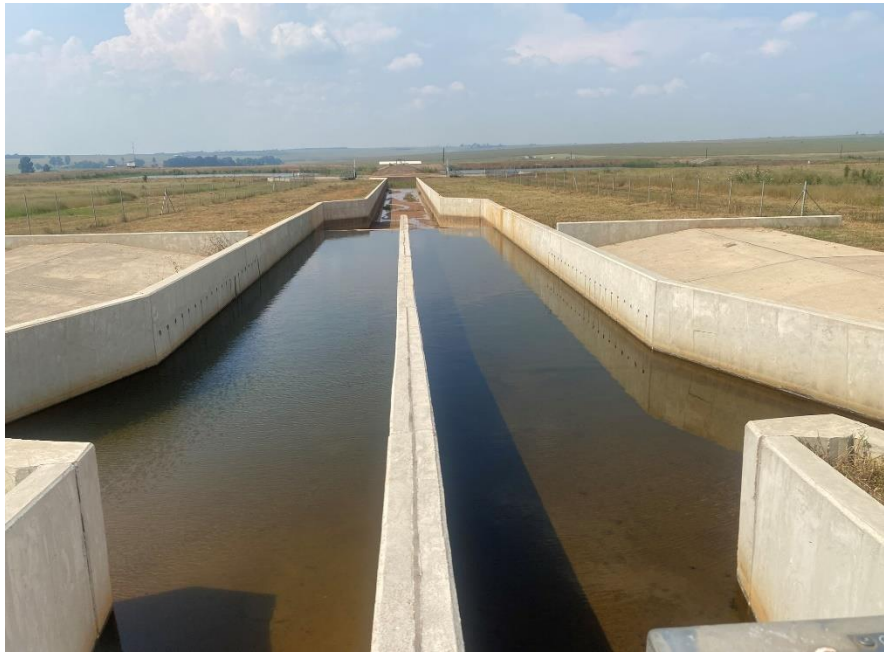
Photo 9: Silt trap

Satisfactory

The concrete structure of the silt trap was observed to be in good condition and well-maintained.

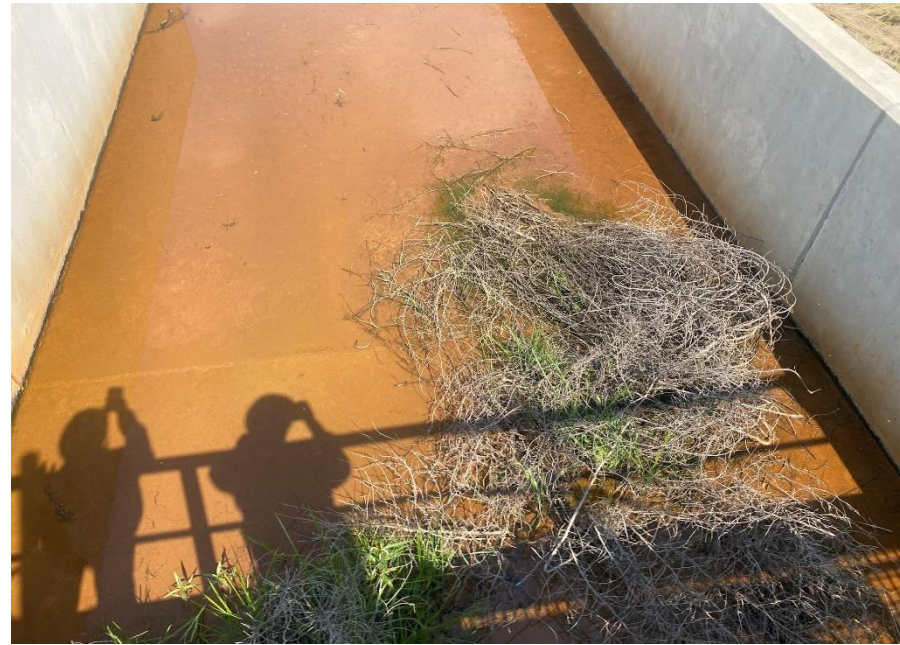
Photo 10: Inlet channel

Unsatisfactory

Vegetation growth observed inside the channel from silt trap compartment to the dam

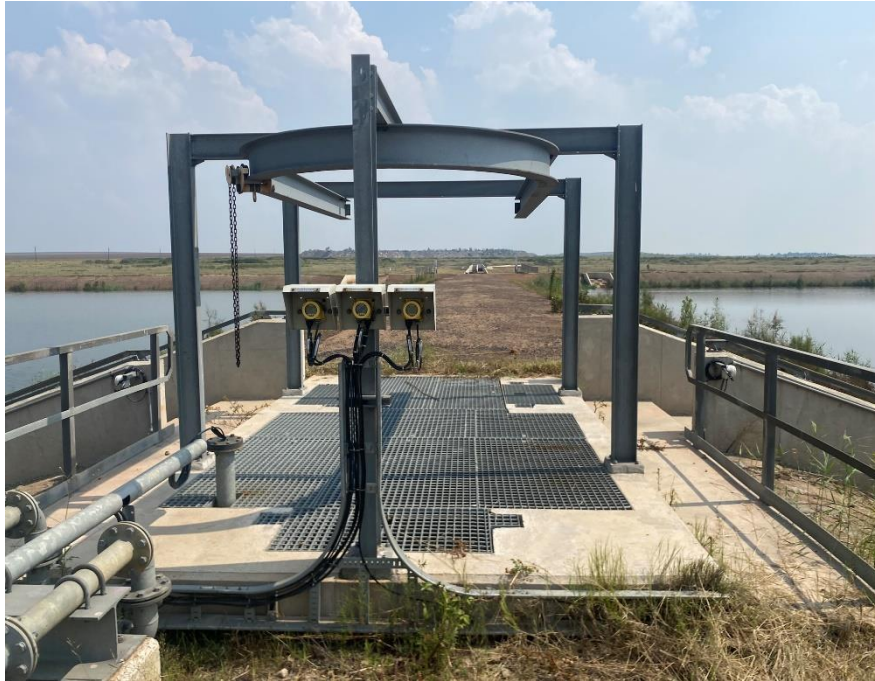
Photo 11: Flow meter

Satisfactory

Flow meter observed. The data should also be recorded and shared with Isithelo

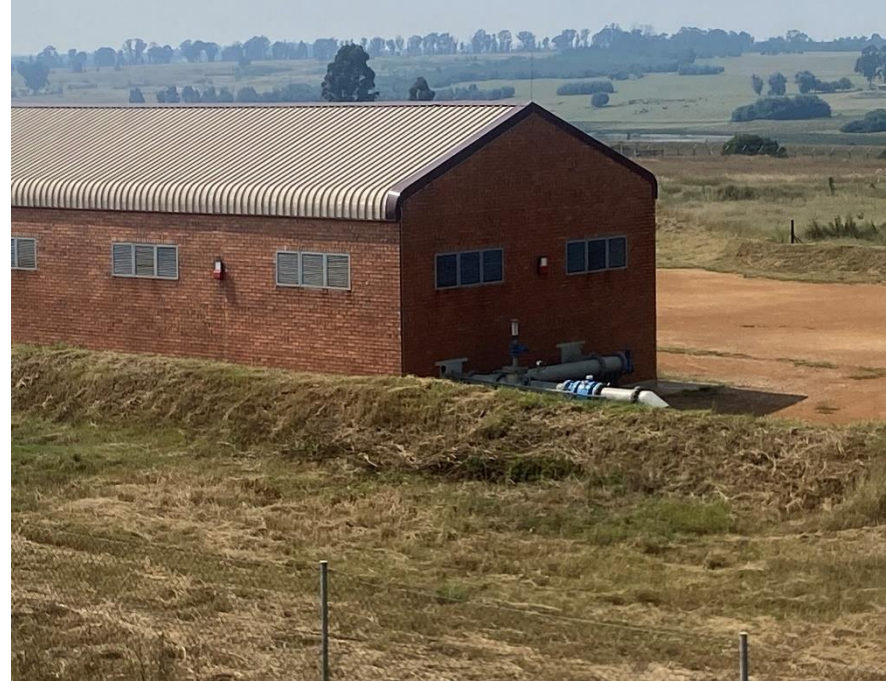
Photo 12: Pumpstation

Satisfactory

No concerns

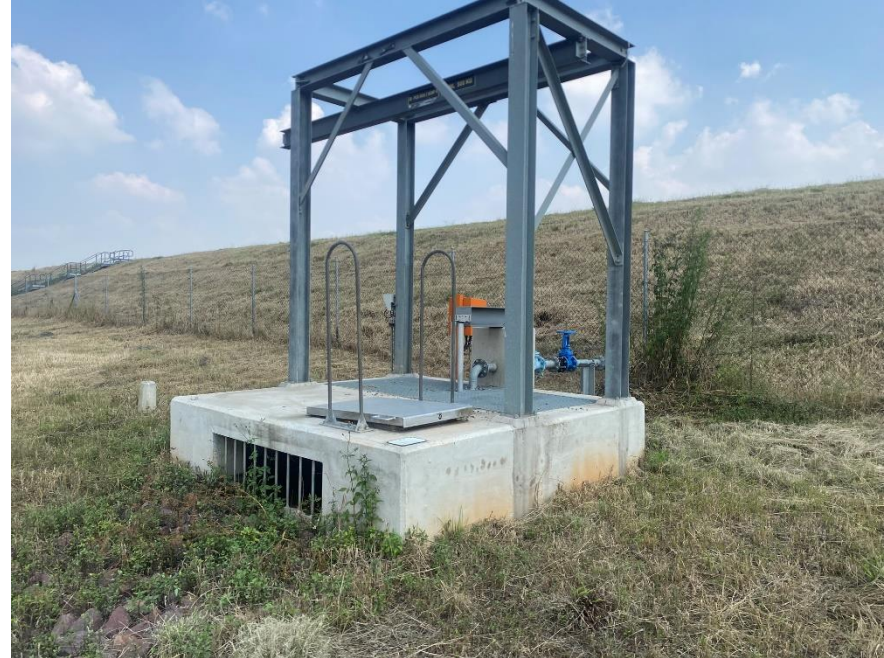
Photo 14: Leakage detector

Satisfactory

No concerns

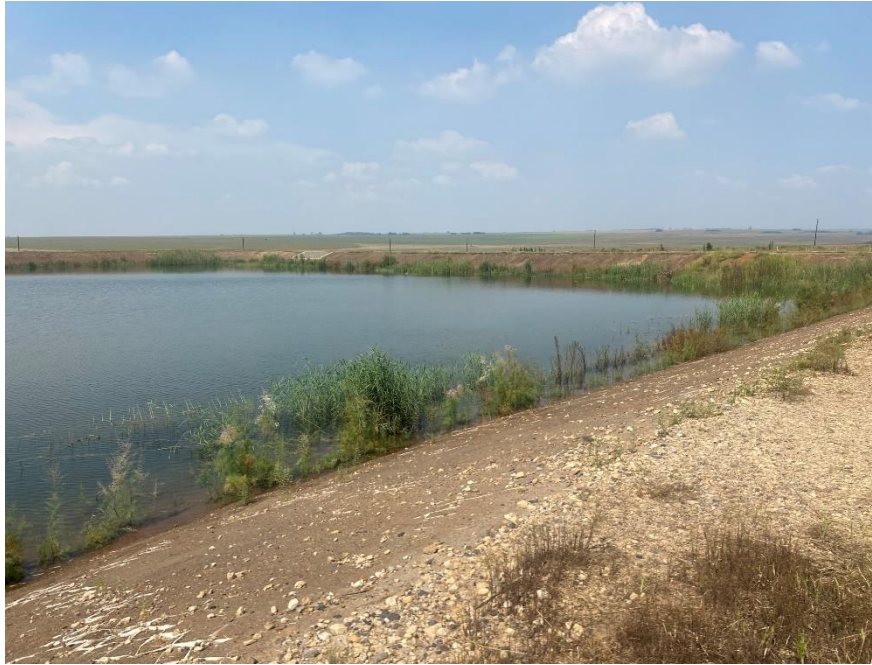
Photo 15: Safety Buoy

Unsatisfactory

No HDPE liner, safety nets, and safety bouys noted. This must be verified against the Seriti safety standard

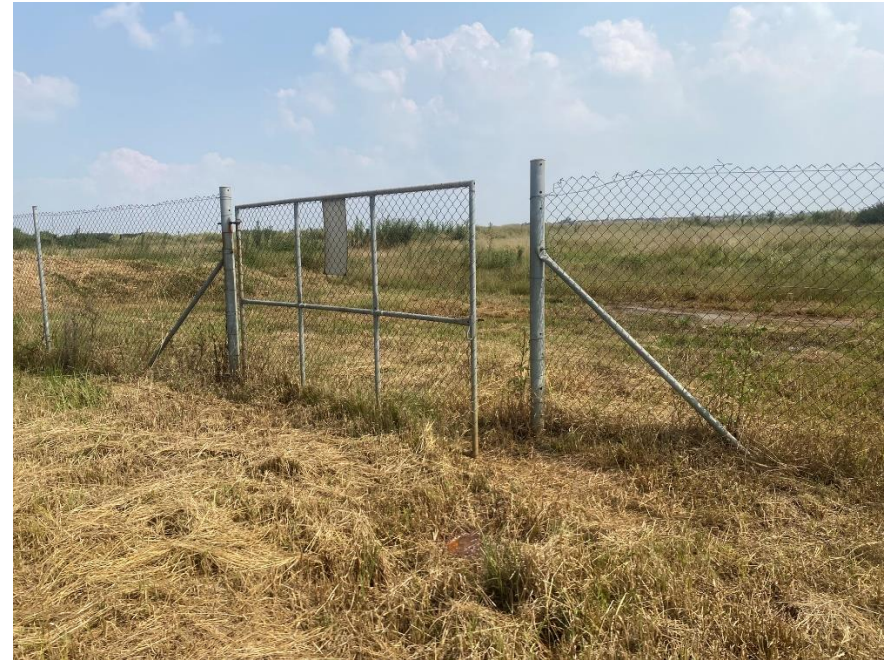
Photo 16: Safety Signage

Unsatisfactory

One of the gates was not locked on the day of the inspection

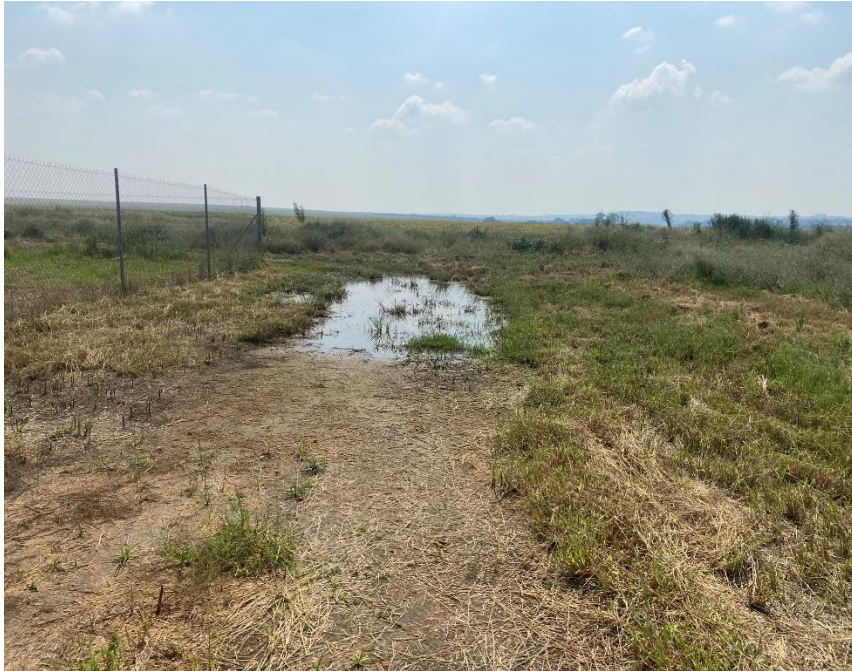
Photo 17: Flow

Unsatisfactory

Water flow was noted near the toe of the northern embankment wall

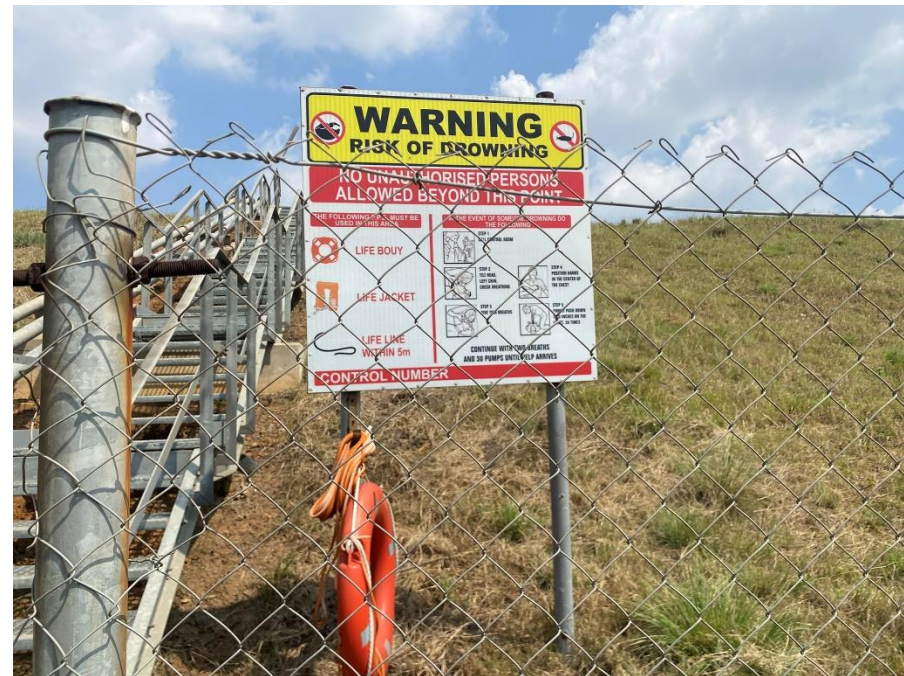
Photo 18: Safety equipment

Unsatisfactory

No emergency numbers observed at the compartment. Emergency numbers are required on the safety board. Additionally, there was no safety case observed

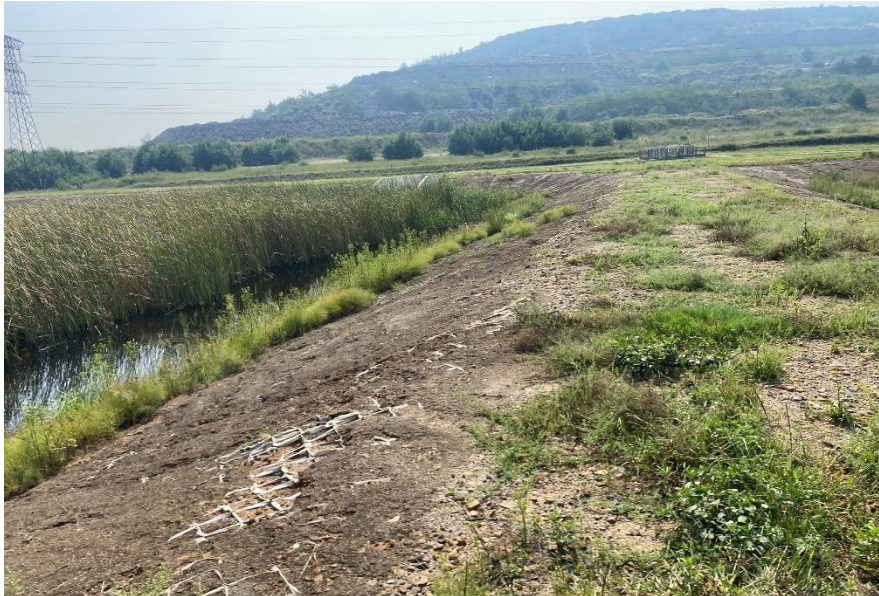
Photo 1: Wall crest condition

Unsatisfactory

An uneven walkway was observed on the crest, which needs to be levelled by adding a 150mm layer of G5 material

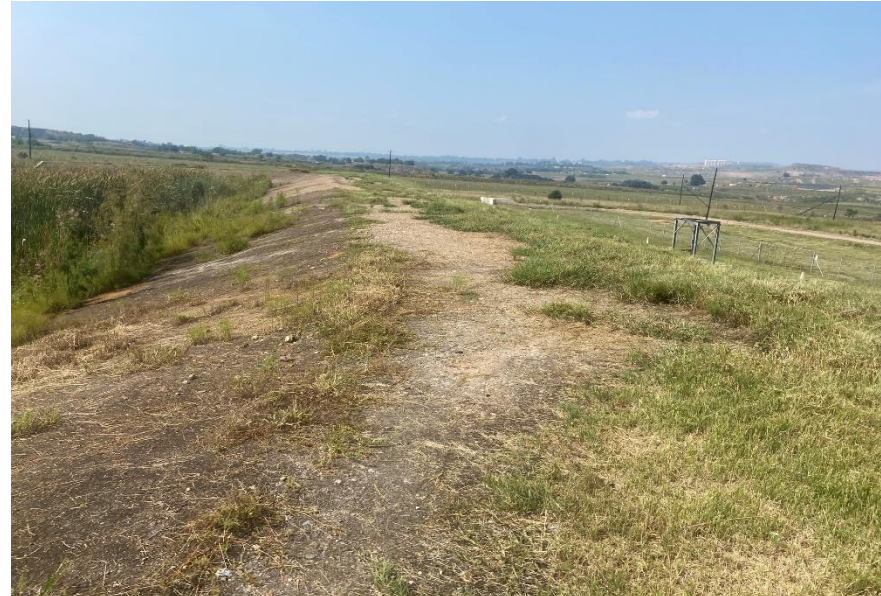
Photo 2: Wall crest condition

Unsatisfactory

Vegetation growth noted on the wall crest

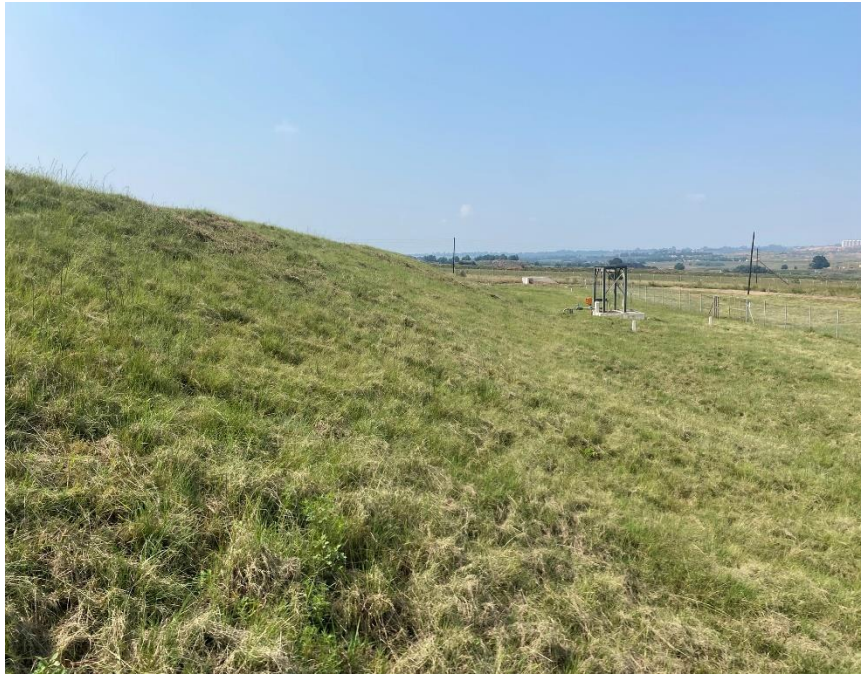
Photo 3: Grass condition

Note:
Grass-cutting were carried out at the time of inspection
