Klipspruit Colliery

Structural Assessment of CV06 N12 BRIDGE

Report Date: 08 August 2025

Klipspruit Colliery- Structural Assessment of CV06 N12 Bridge

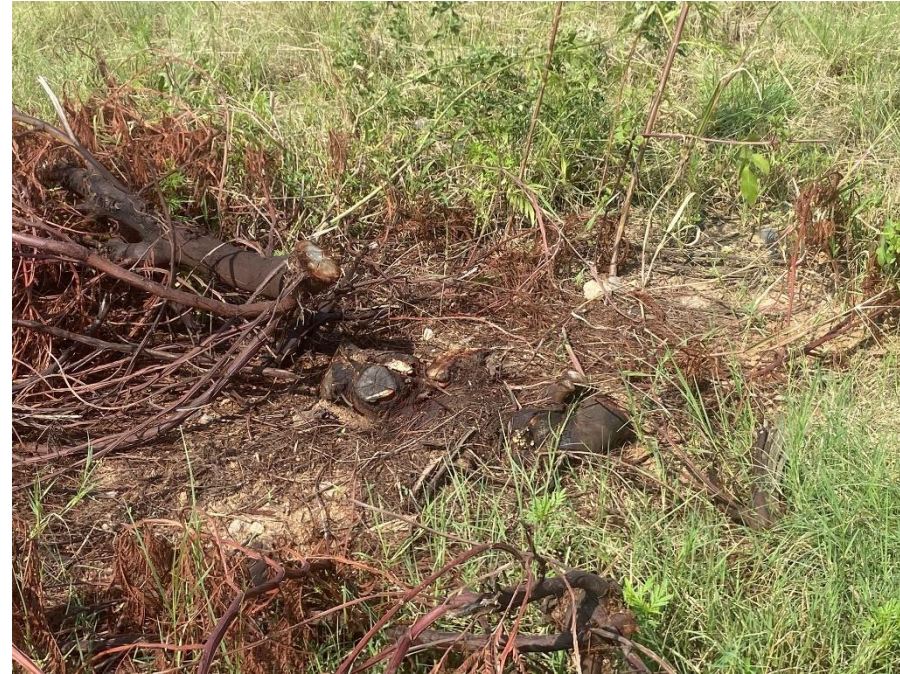
Photo 4: Vegetation

Unsatisfactory
Vegetation noted on the inside and outside wall. The vegetation needs to be removed and treated

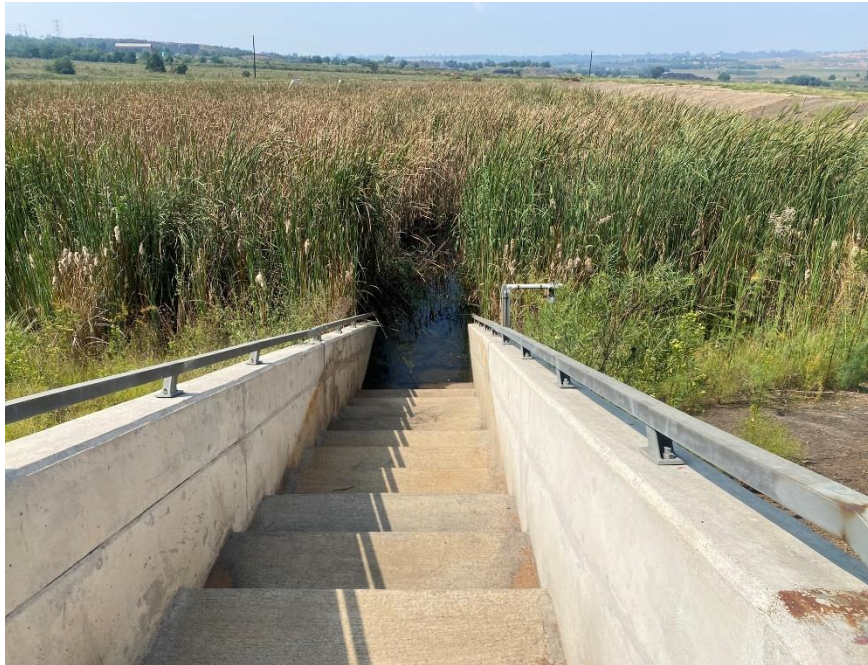
Photo 5: Dam basin

Unsatisfactory
Reeds observed at the dam basin

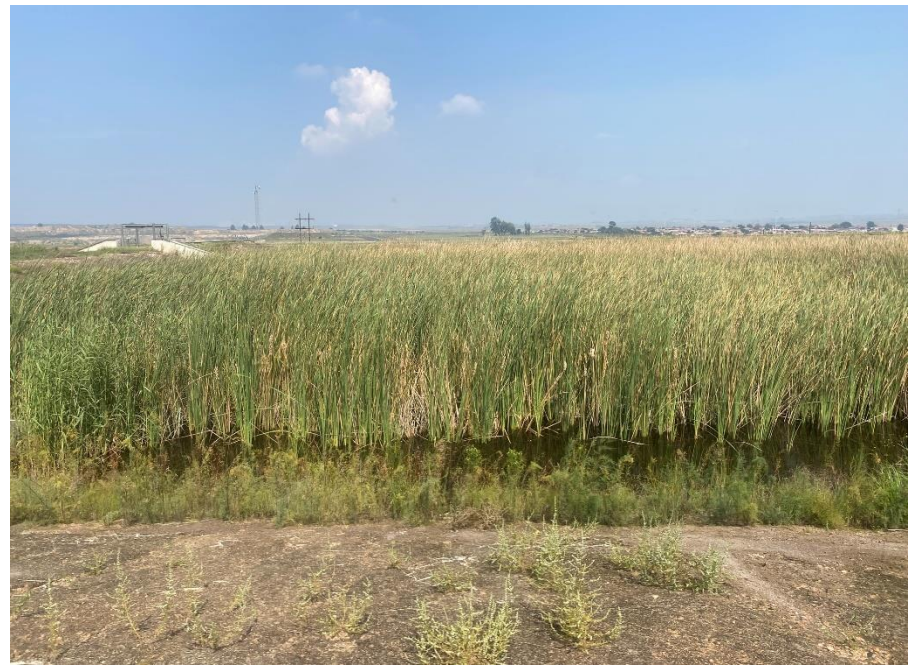
Photo 6: Dam basin

Unsatisfactory
Reeds observed at the dam basin

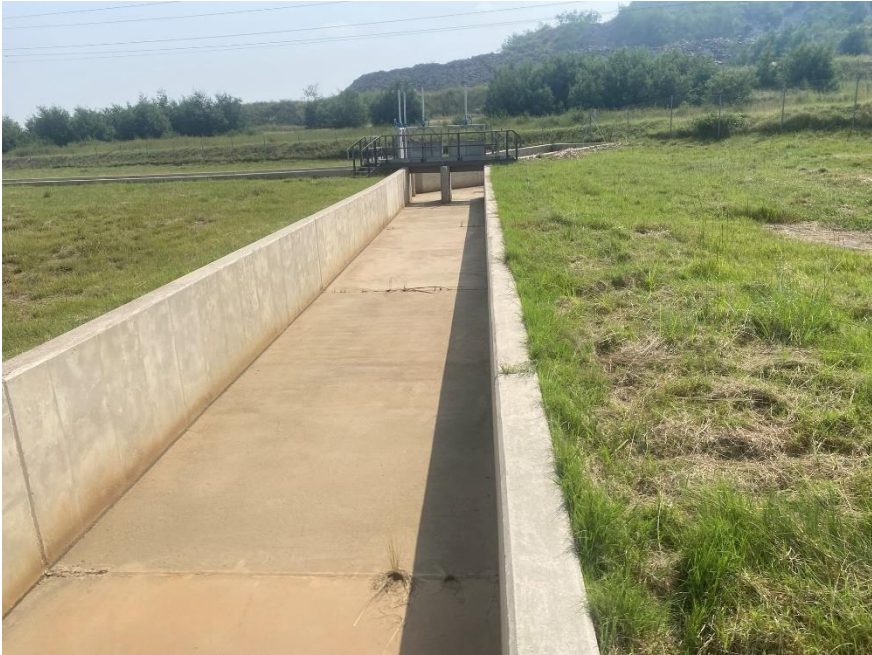
Photo 7: Inlet channel

Unsatisfactory

Concrete channels were well maintained. However, minor vegetation growth was observed on the joints. Additionally, the sluice gates were both open on the day of the inspection

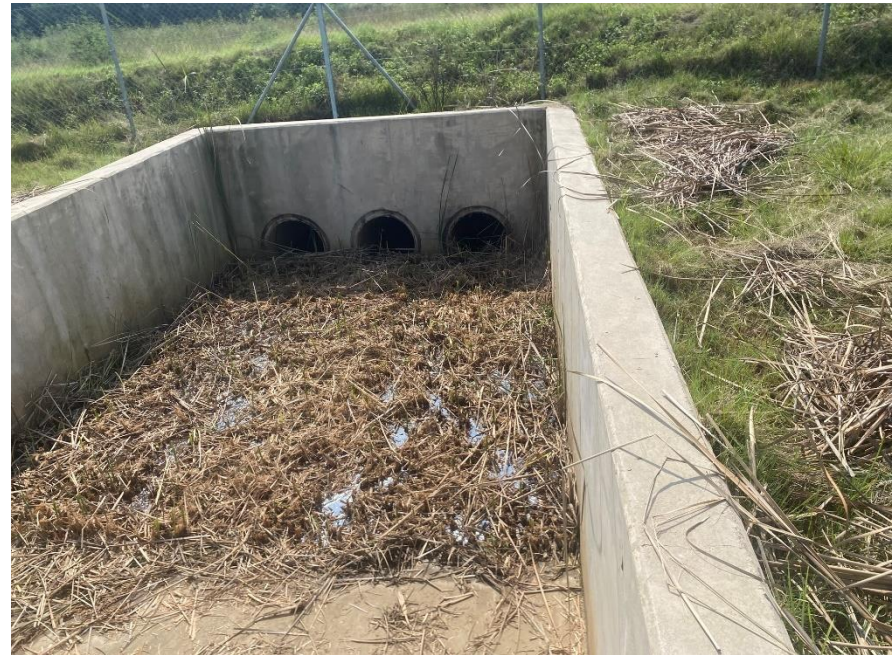
Photo 8: Inlet pipes

Incomplete

Vegetation has been removed from the rip-rap. However, silt was observed accumulating inside the pipes

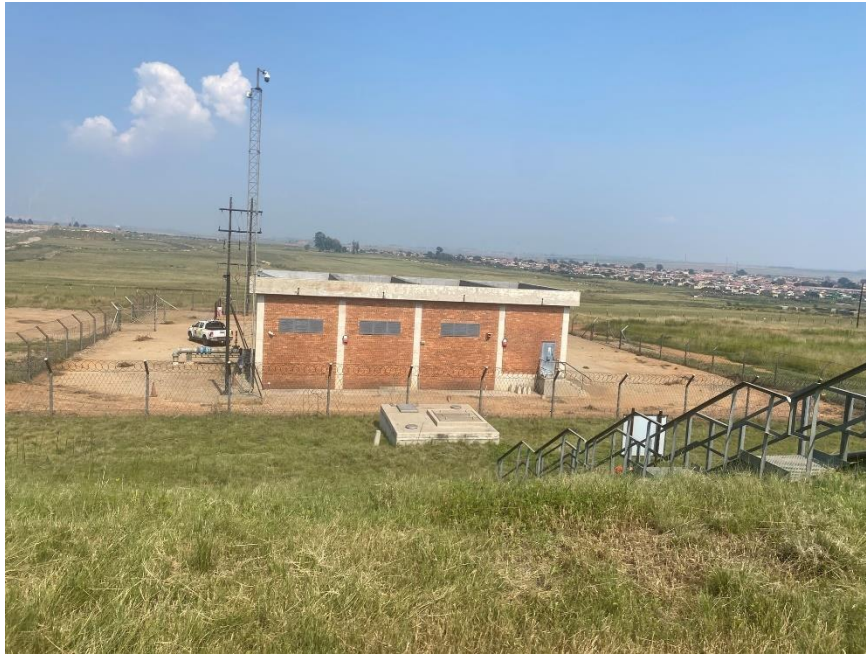
Photo 9: Pumstation

Satisfactory
No leakages noted

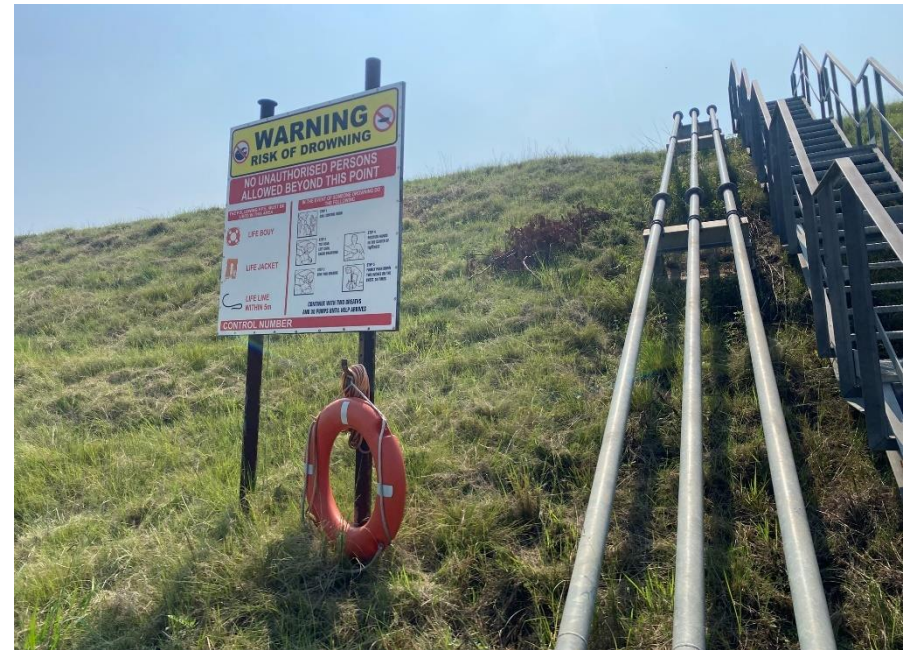
Photo 10: Outlet pipes

Satisfactory
No concerns

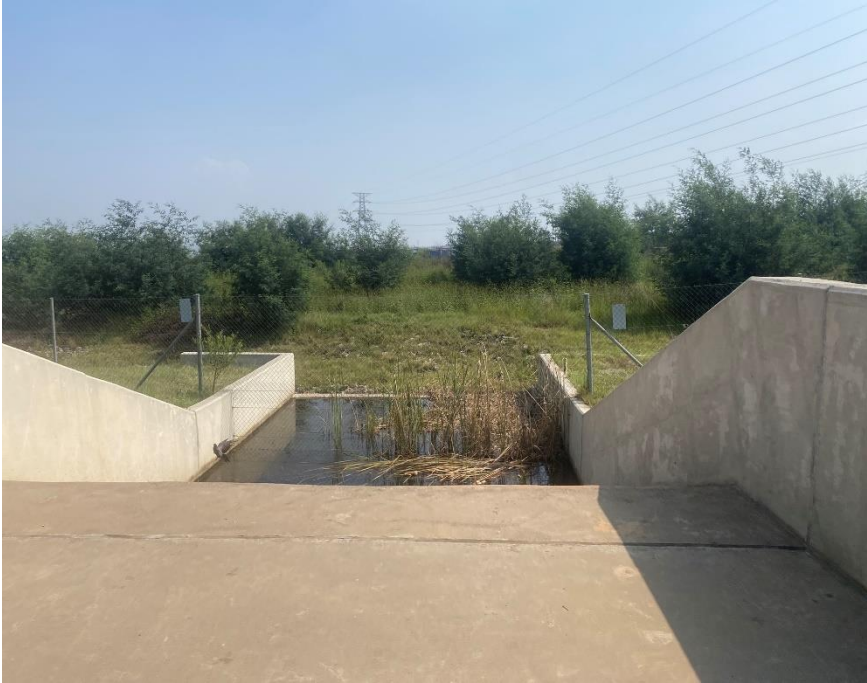
Photo 11: Outflow spillway

Unsatisfactory

Minor reeds were noted on the spillway at compartment A. Reeds should be removed to prevent any blockages

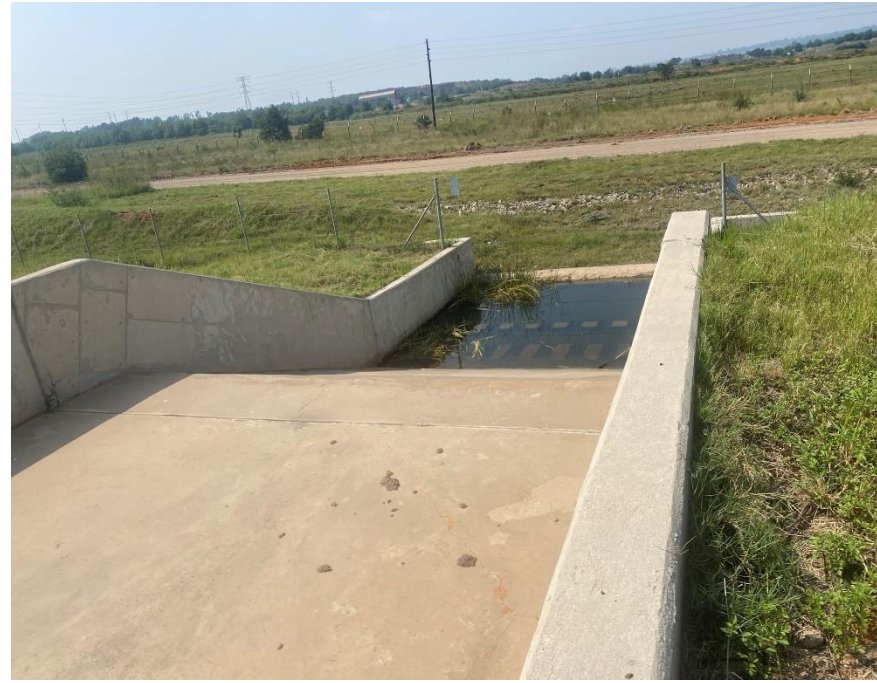
Photo 12: Outflow spillway

Unsatisfactory

Minor reeds were noted on the spillway at compartment B. Reeds should be removed to prevent any blockages

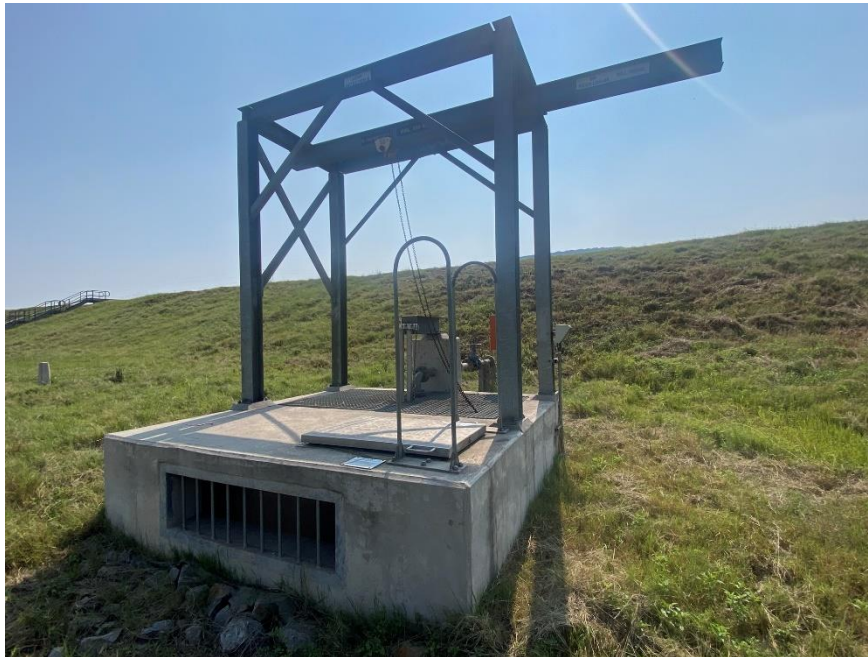
Photo 13: Leakage detectors

Satisfactory
No concerns

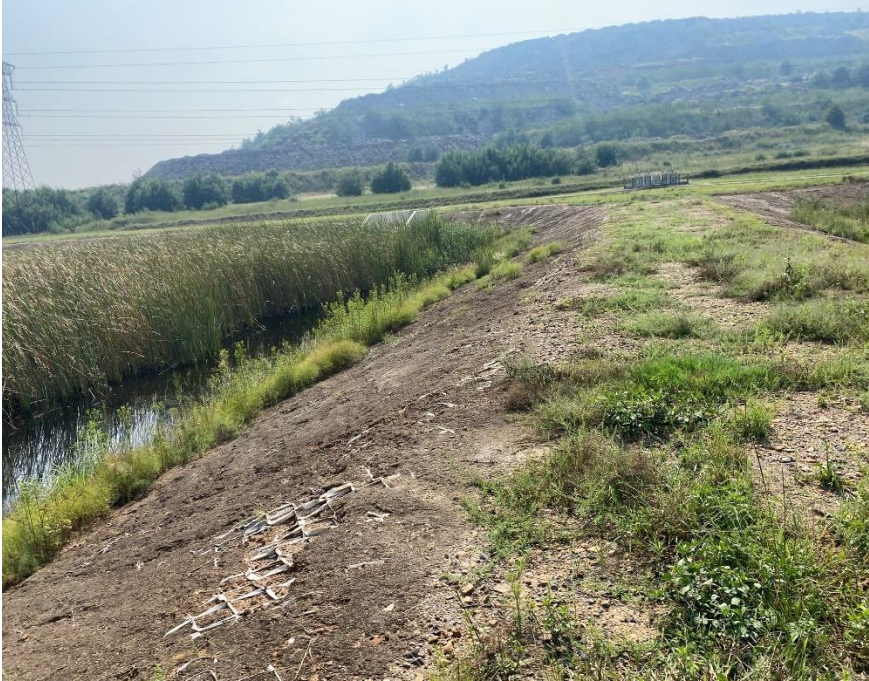
Photo 15: Safety Buoy

Unsatisfactory

No HDPE liner, safety nets, and safety bouys noted. This must be verified against the Seriti safety standard

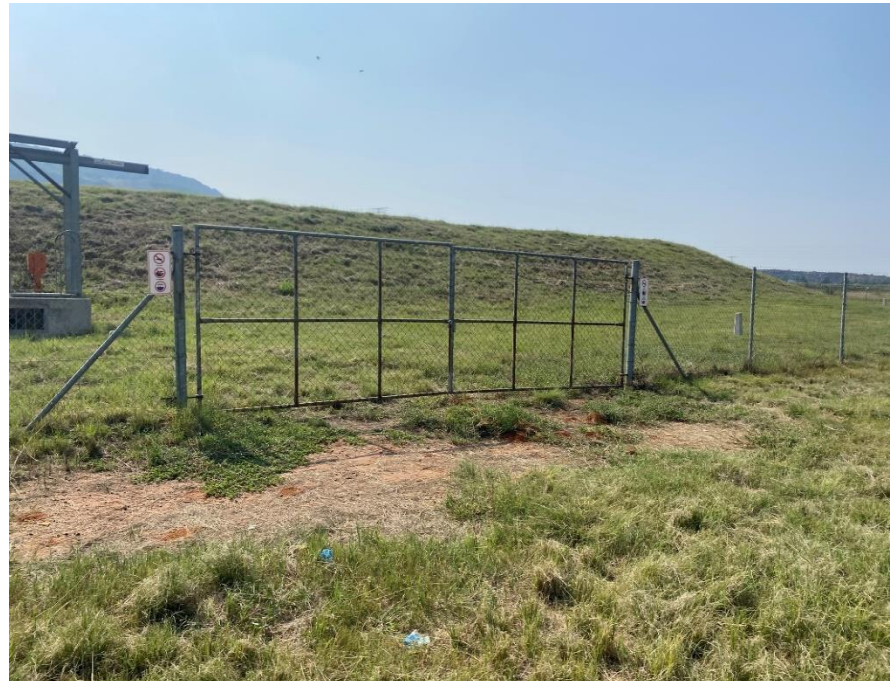
Photo 16: Safety Signage

Unsatisfactory

“No Entry” signage missing at the entrance. Adequate signage is required

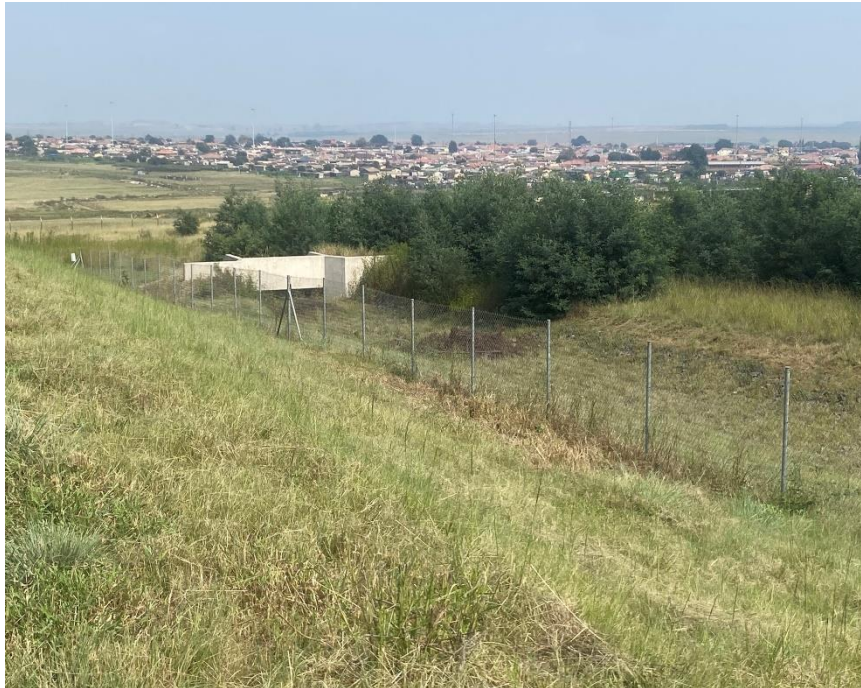
Photo 17: Fence

Satisfactory

Adequate access control was observed on-site

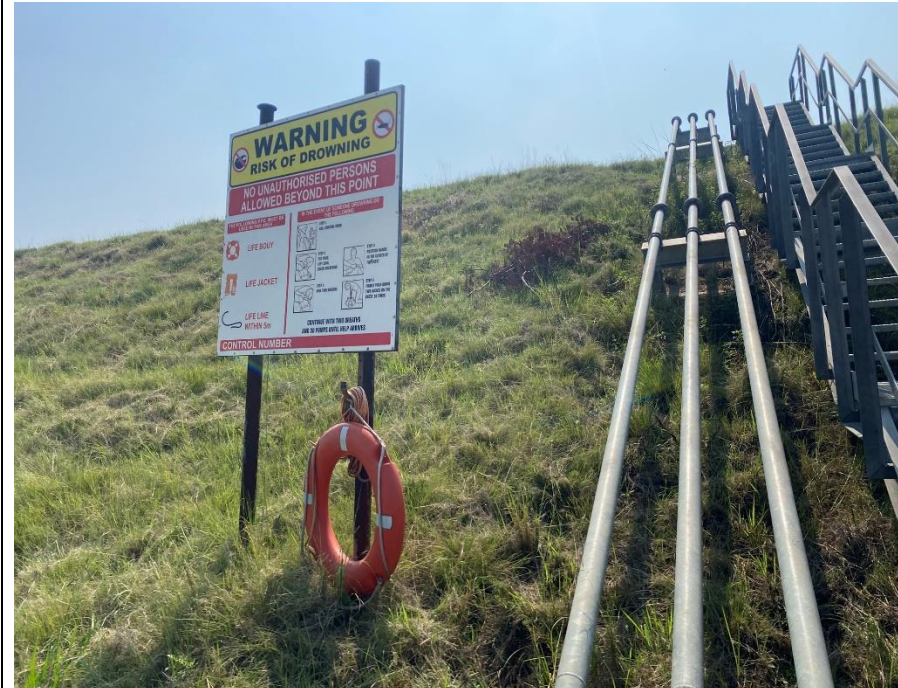
Photo 18: Safety equipment

Unsatisfactory

No emergency numbers observed at the compartment. Emergency numbers are required on the safety board. Additionally, there was no safety case observed

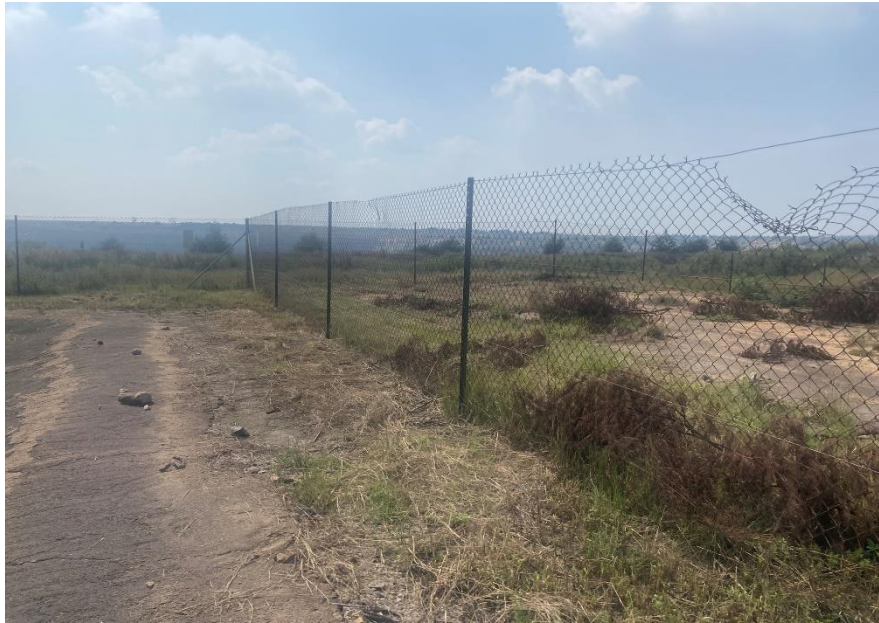
Photo 1: Wall crest condition

Satisfactory
No concerns

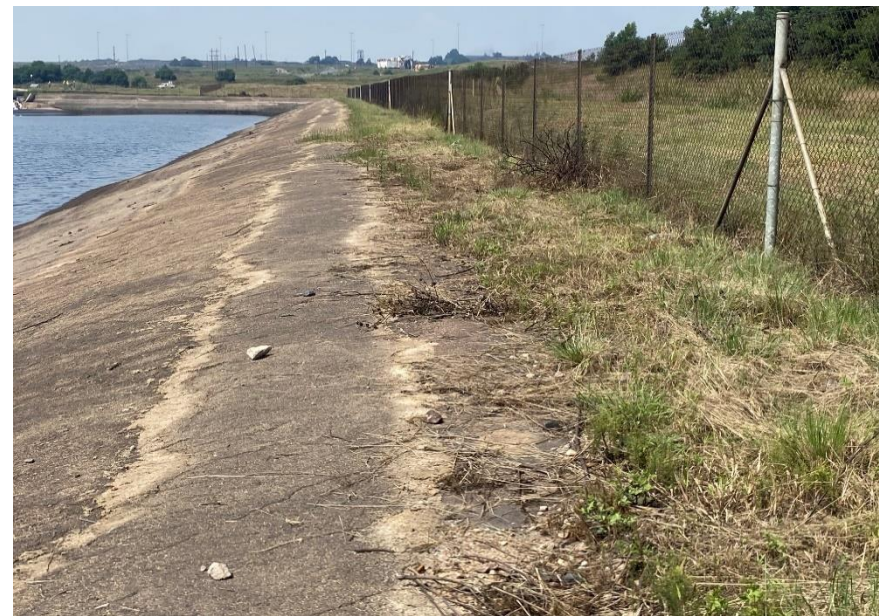
Photo 2: Wall crest condition

Unsatisfactory
Lateral cracks observed on the concrete

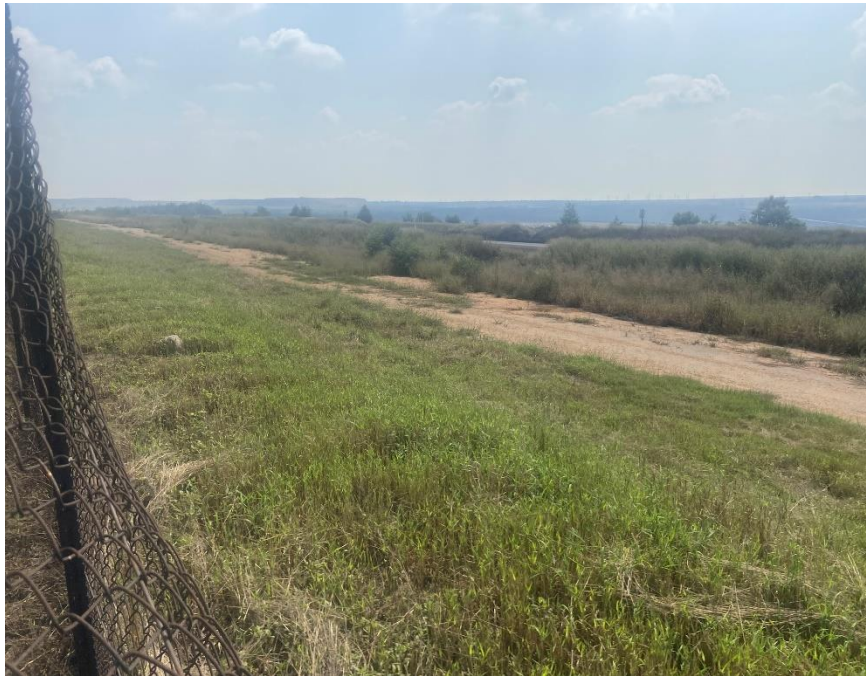
Photo 3: Grass condition

Note:
Grass-cutting were carried out at the time of inspection

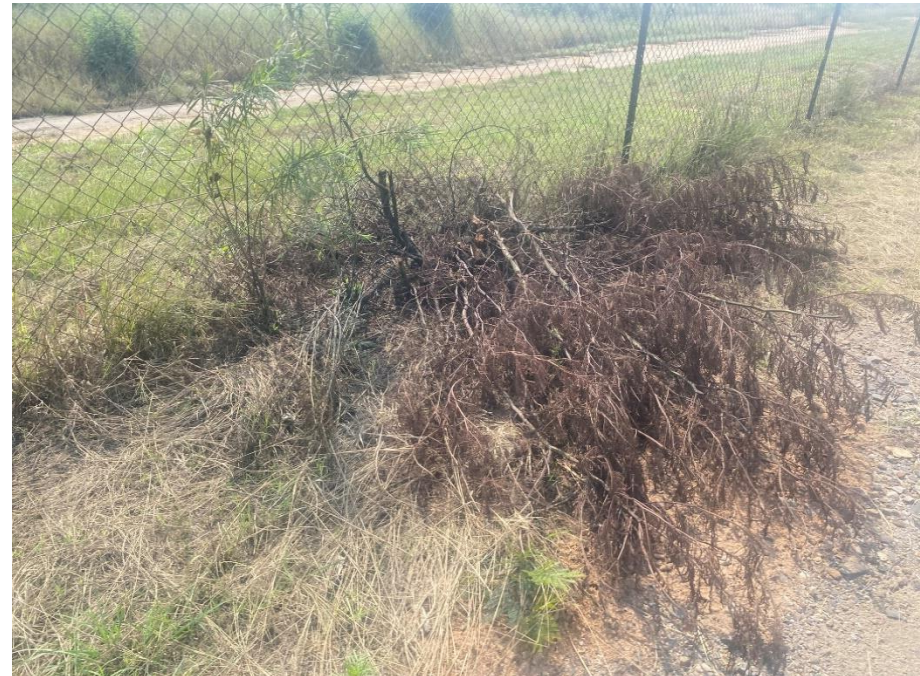
Photo 4: Vegetation

Unsatisfactory
Vegetation noted on the inside and outside wall. The vegetation needs to be removed and treated

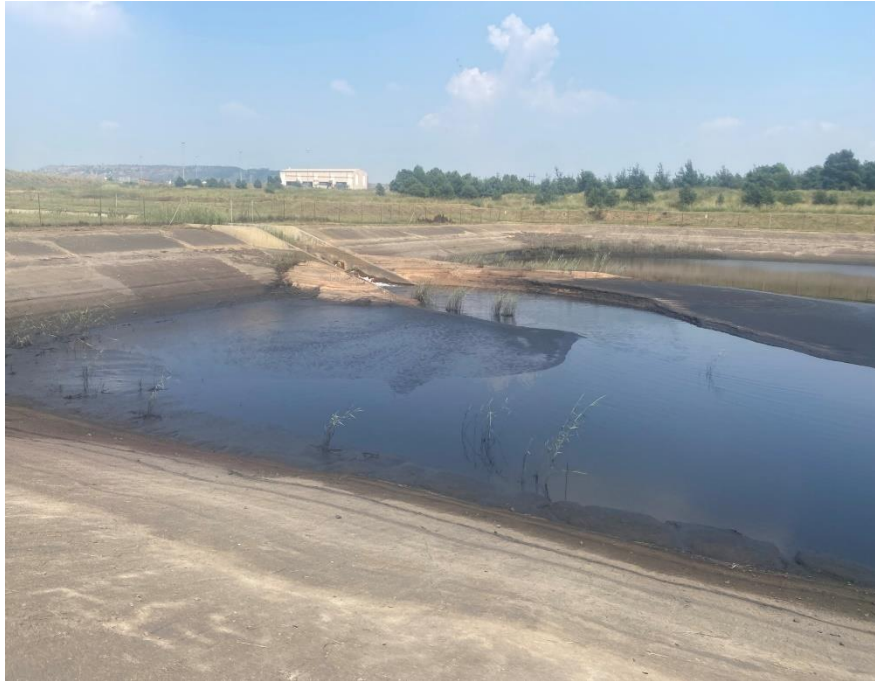
Photo 5: Dam basin

Unsatisfactory

Silt accumulation observed inside the dam basin

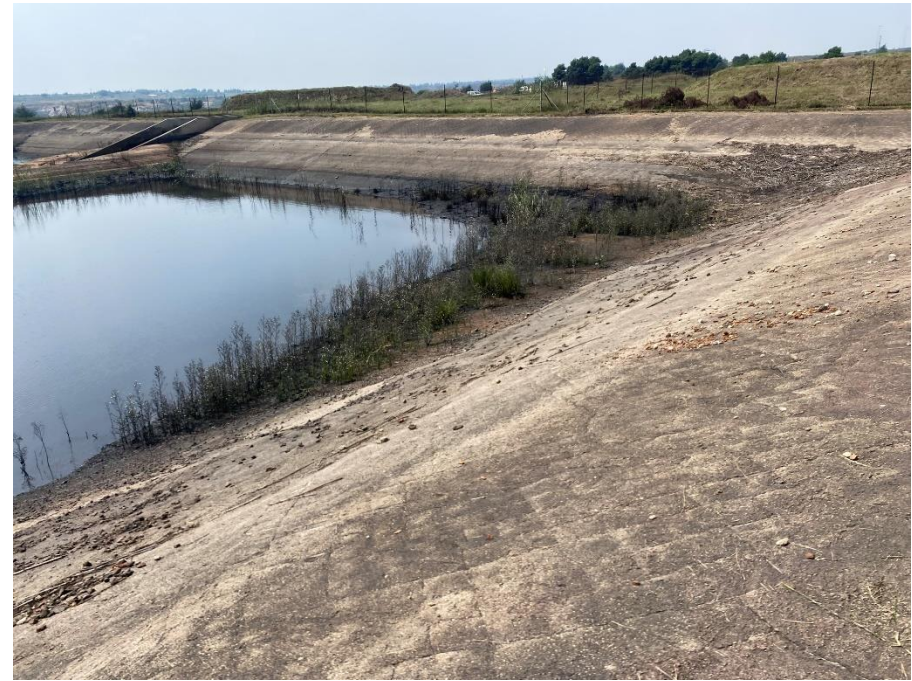
Photo 6: Dam basin

Unsatisfactory

Reeds observed growing inside the dam basin

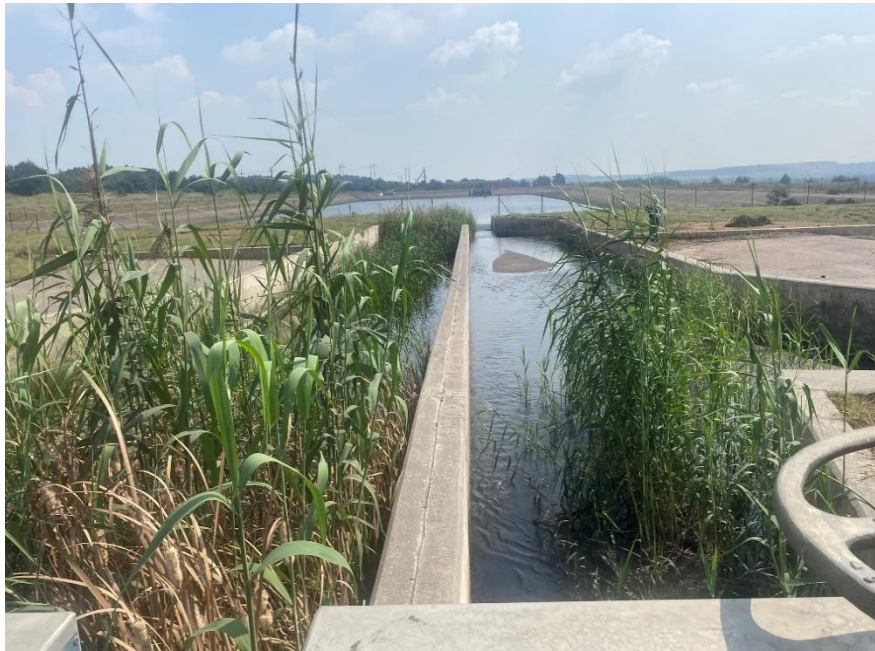
Photo 9: Silt trap

Unsatisfactory
Excessive reeds observed inside the silt trap compartment

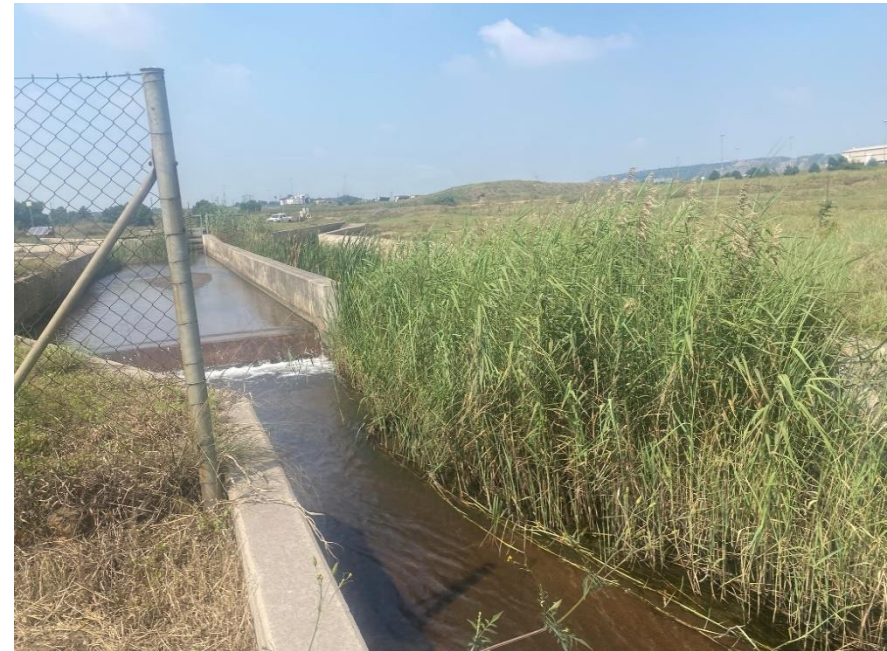
Photo 10: Inlet channel

Unsatisfactory
Excessive reeds observed inside the channel from silt trap compartment to the dam

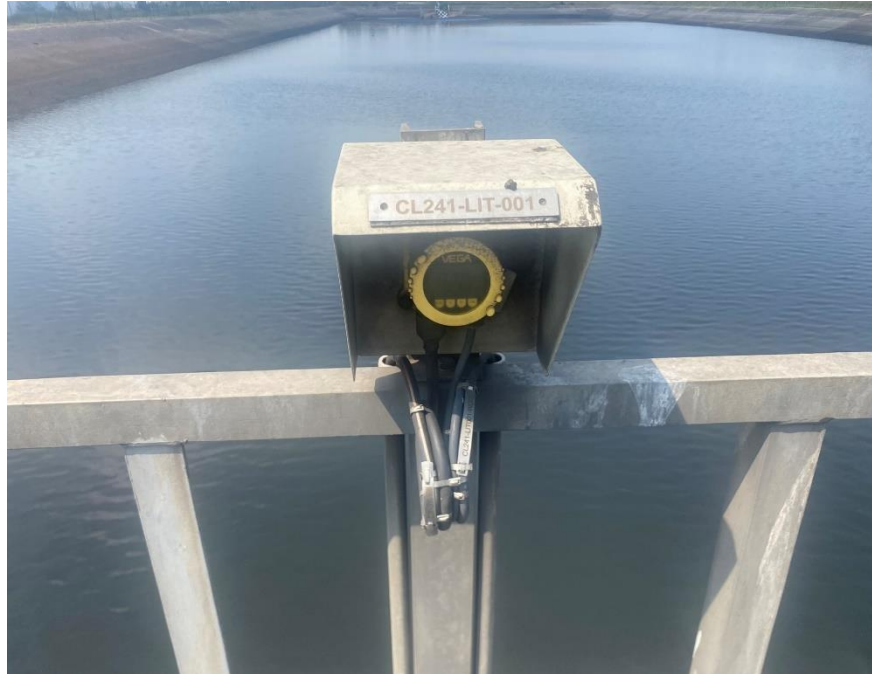
Photo 11: Flow meter

Satisfactory

Flow meter observed. The data should also be recorded and shared with Isithelo

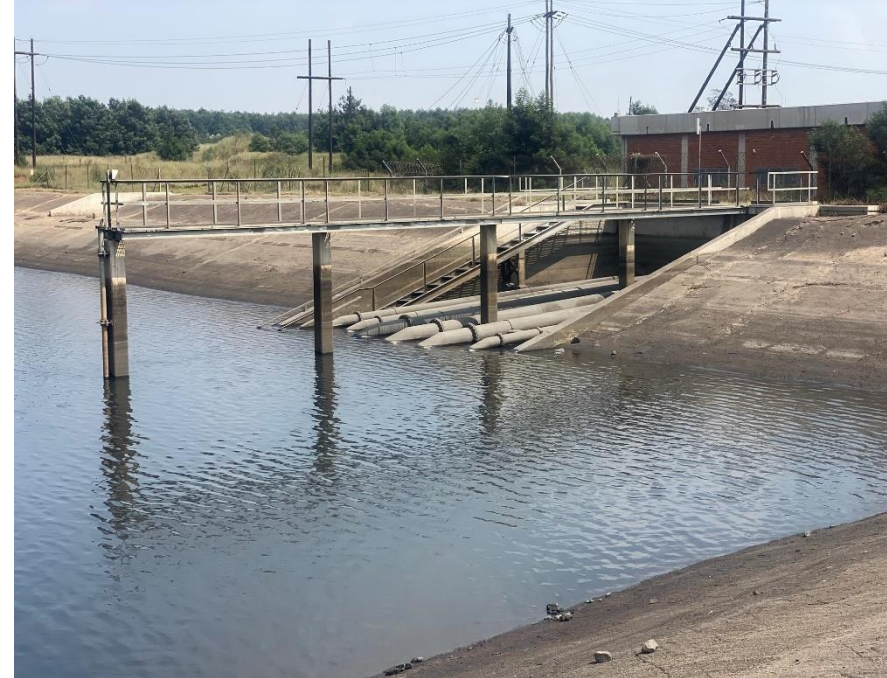
Photo 12: Outlet works

Satisfactory

No concerns

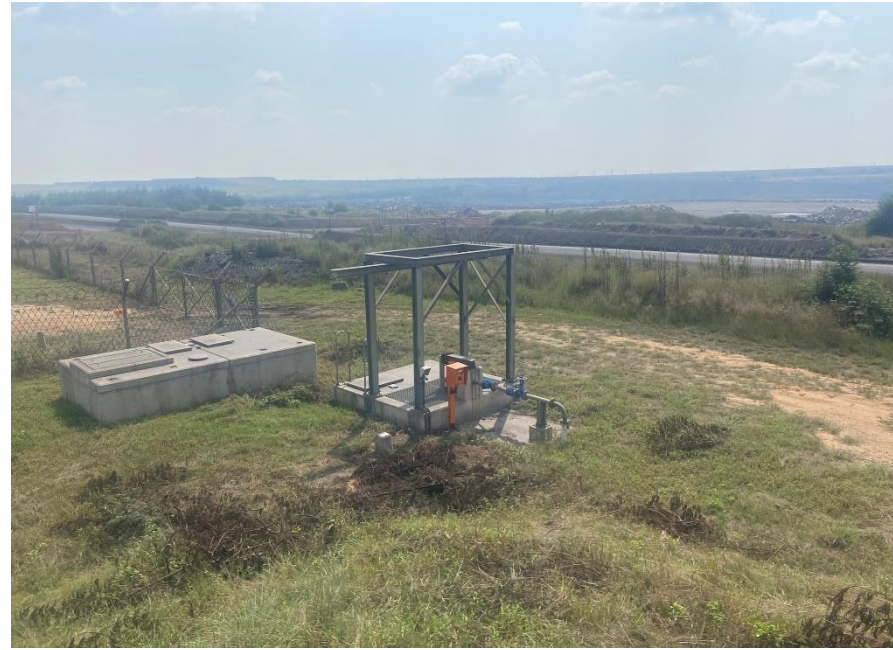
Photo 14: Leakage detector

Satisfactory

No concerns

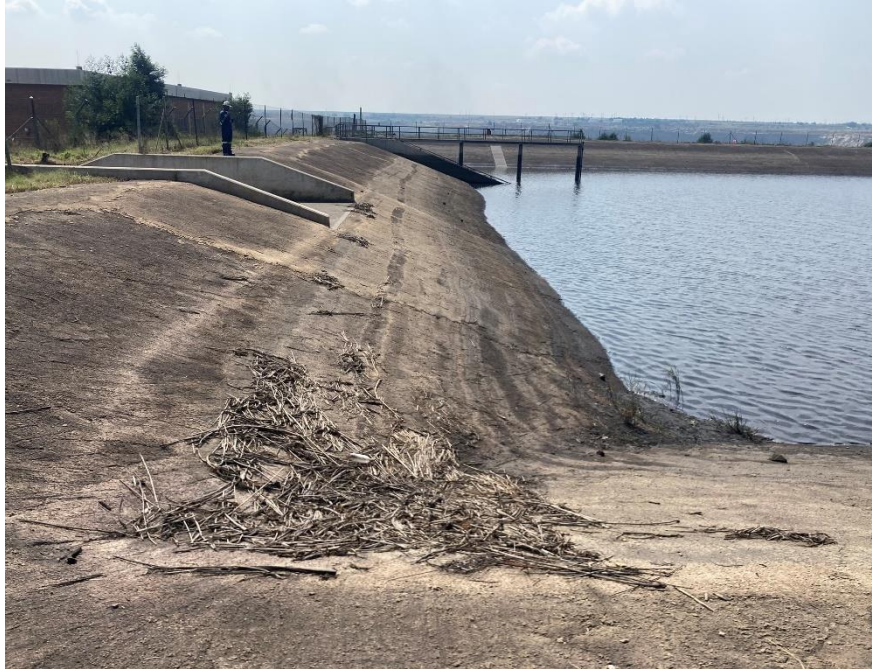
Photo 15: Safety Buoy

Unsatisfactory

No HDPE liner, safety nets, and safety buoys noted. This must be verified against the Seriti safety standard

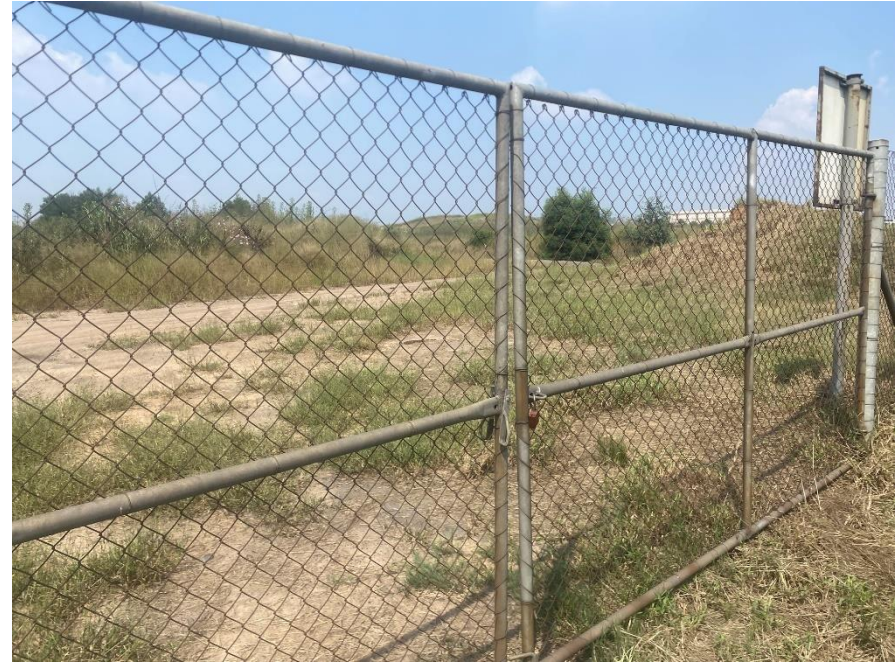
Photo 16: Safety Signage

Unsatisfactory

"No Entry" signage missing at the entrance. Additionally, one of the gates was not locked on the day of the inspection

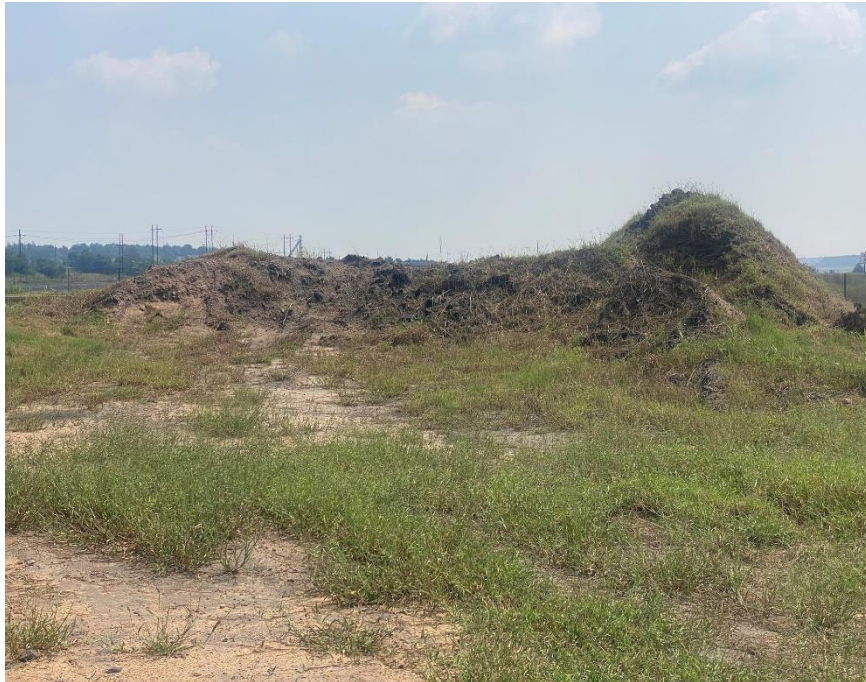
Photo 17: Housekeeping

Unsatisfactory

Heaps of silt observed placed directly in contact with the ground

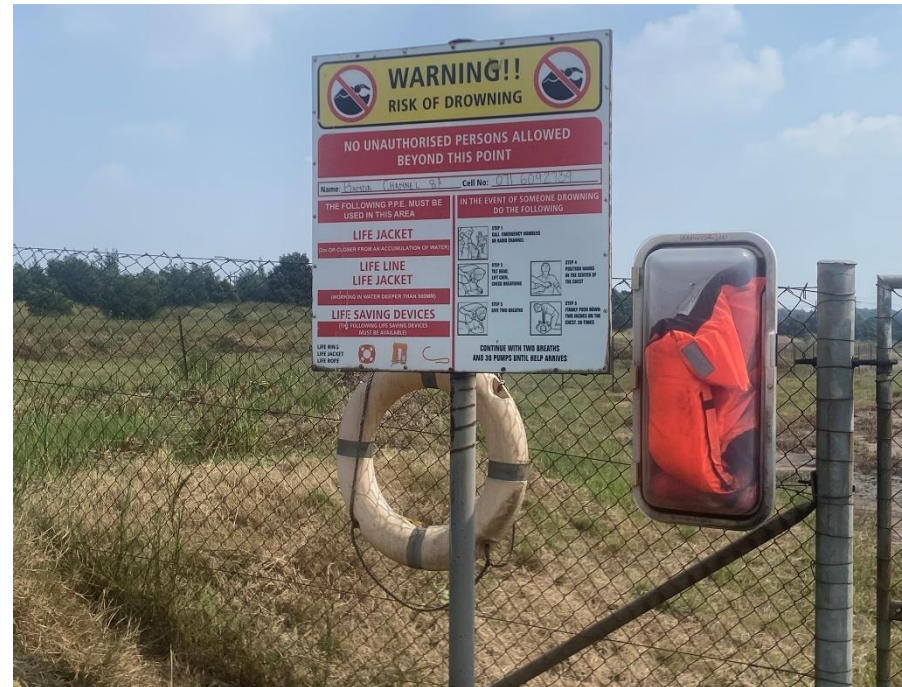
Photo 18: Safety equipment

Unsatisfactory

No emergency numbers observed at the compartment. Emergency numbers are required on the safety board. Additionally, there was no safety case observed
