Klipspruit Colliery

Structural Assessment of CV06 N12 BRIDGE

Report Date: 08 August 2025

Klipspruit Colliery- Structural Assessment of CV06 N12 Bridge

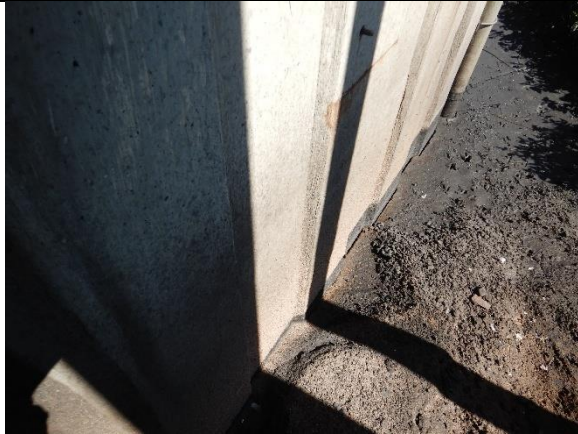
Fig.3.5: Base of the concrete pier

Condition Category:	2	Priority:	3
Recommendation:		Risk Rating:	9

Continue with routine inspections to ensure the base of the pier remains free from structural defects. Monitor for any future signs of distress or ground movement and ensure proper site drainage to prevent moisture accumulation around the pier foundation.

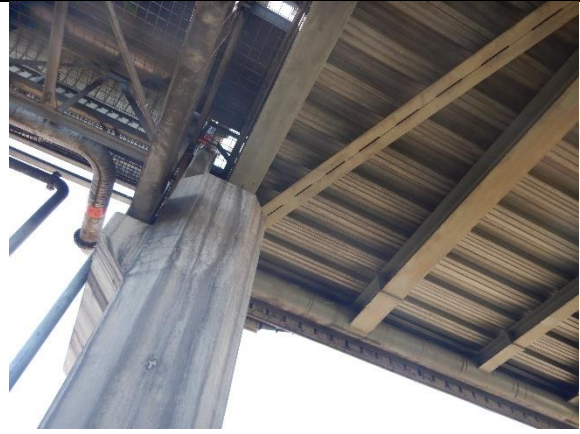
Fig.3.6: Pier cap

Condition Category:	2	Priority:	2
Recommendation:		Risk Rating:	9

Maintain periodic visual inspections of the pier cap to monitor for any early signs of structural distress, such as cracking, spalling, or settlement.

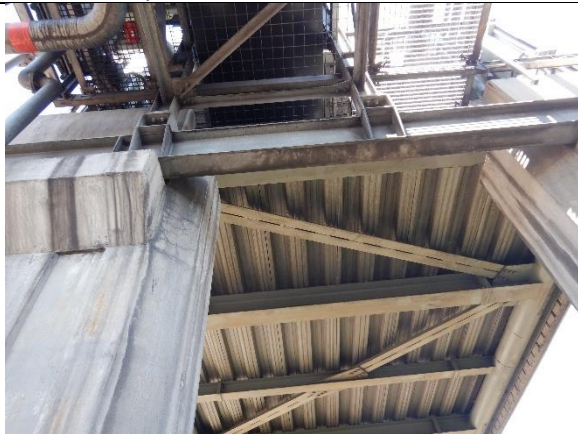
Fig.3.7: Pier cap

Condition Category:	2	Priority:	3
Recommendation:		Risk Rating:	9

Continue to monitor the condition of the beam girder through scheduled inspections to ensure early detection of any potential deterioration.

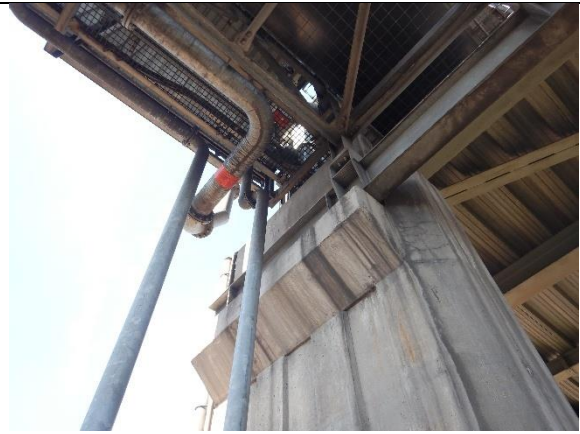
Fig.3.8: Bridge beams

Condition Category:	2	Priority:	3
Recommendation:		Risk Rating:	9

Continue with routine inspections to ensure the base of the pier remains free from structural defects. Monitor for any future signs of distress or ground movement.

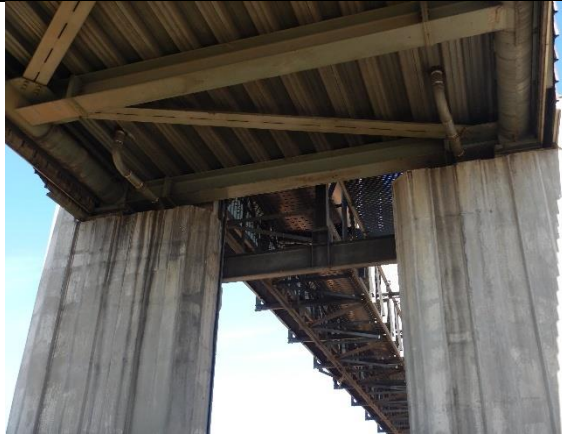
Fig. 3.13: Piers

Condition Category:	2	Priority:	3
Recommendation:		Risk Rating:	9

Continue regular inspections of the piers to monitor the extent of surface staining. No immediate remedial action is required, but periodic assessment is recommended.

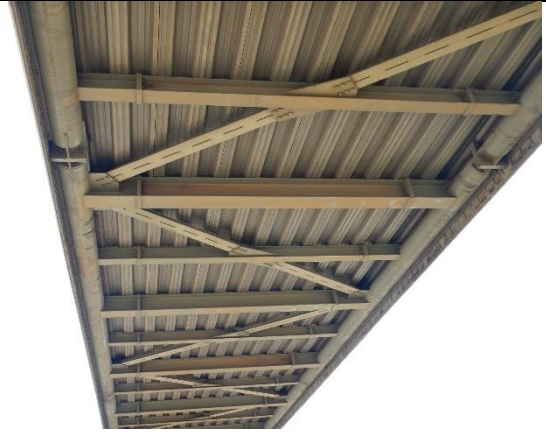
Fig. 3.14: Floor beams and cross bracing

Condition Category:	2	Priority:	3
Recommendation:		Risk Rating:	9

Maintain a routine inspection schedule for the steel structural members to monitor for any future signs of corrosion, fatigue, or connection loosening. Ensure protective coatings are intact, particularly at joints and exposed areas.

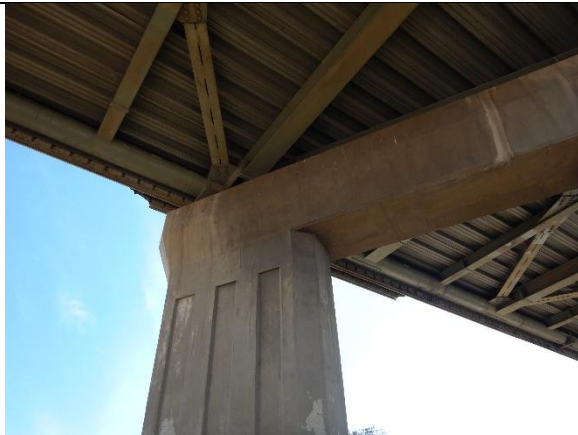
Fig. 3.15: Concrete pier cap

Condition Category:	2	Priority:	3
Recommendation:		Risk Rating:	9

Continue periodic inspections of the bearing seat to ensure it remains structurally sound and free from signs of wear, cracking, or displacement.

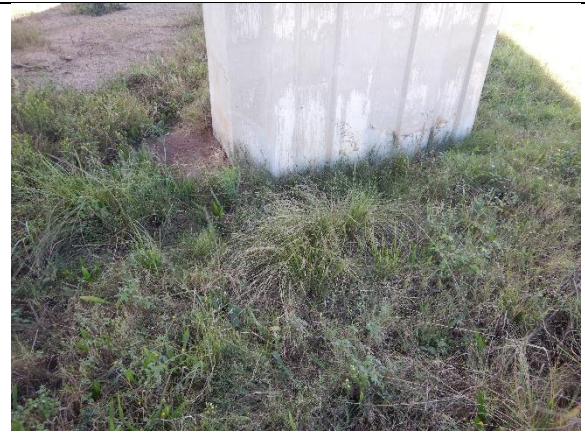
Fig.3.16: Base of the concrete pier

Condition Category:	2	Priority:	3
Recommendation:		Risk Rating:	9

Continue with routine inspections to ensure the base of the pier remains free from structural defects. Monitor for any future signs of distress or ground movement.

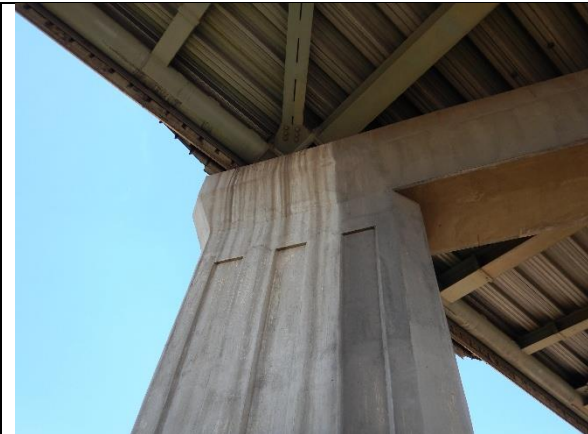
Fig. 3.17: Concrete pier cap

Condition Category:	2	Priority:	3
Recommendation:	Risk Rating:		9

Continue periodic inspections of the pier cap to ensure it remains structurally sound and free from signs of wear, cracking, or displacement.

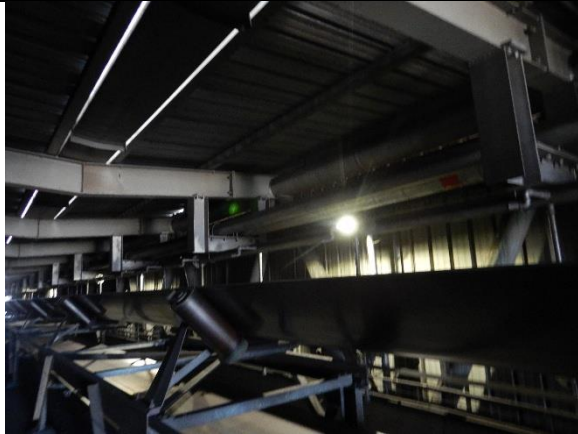
Fig. 3.21: Interior of the enclosed walkway structure

Condition Category:	2	Priority:	3
Recommendation:		Risk Rating:	9

Perform routine inspections of the structure to ensure continued structural integrity. Monitor for potential issues such as corrosion, loose

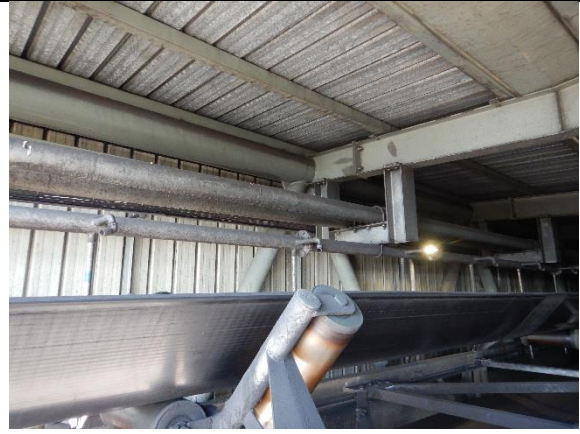
Fig. 3.22: Interior of the enclosed walkway structure

Condition Category:	2	Priority:	3
Recommendation:		Risk Rating:	9

Perform routine inspections of the structure to ensure continued structural integrity.

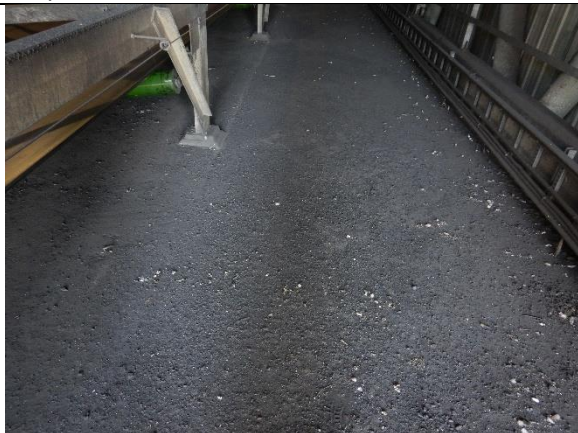
Fig. 3.23: Surface of the deck

Condition Category:	2	Priority:	3
Recommendation:		Risk Rating:	9

Continue with regular inspections of the deck to monitor for any early signs of cracking, surface wear, or deterioration.

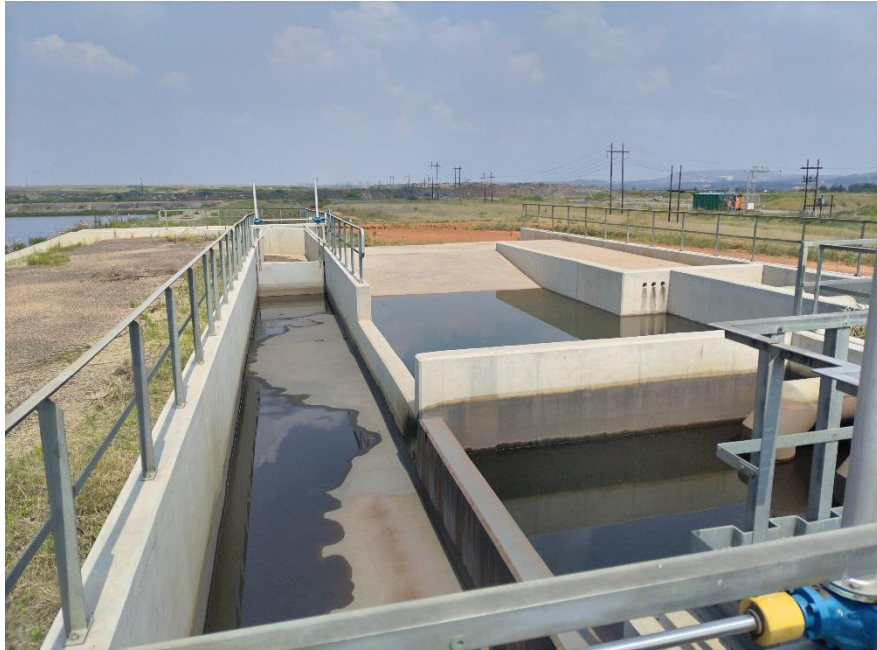
Photo 7: Inlet channel

Satisfactory
No concerns

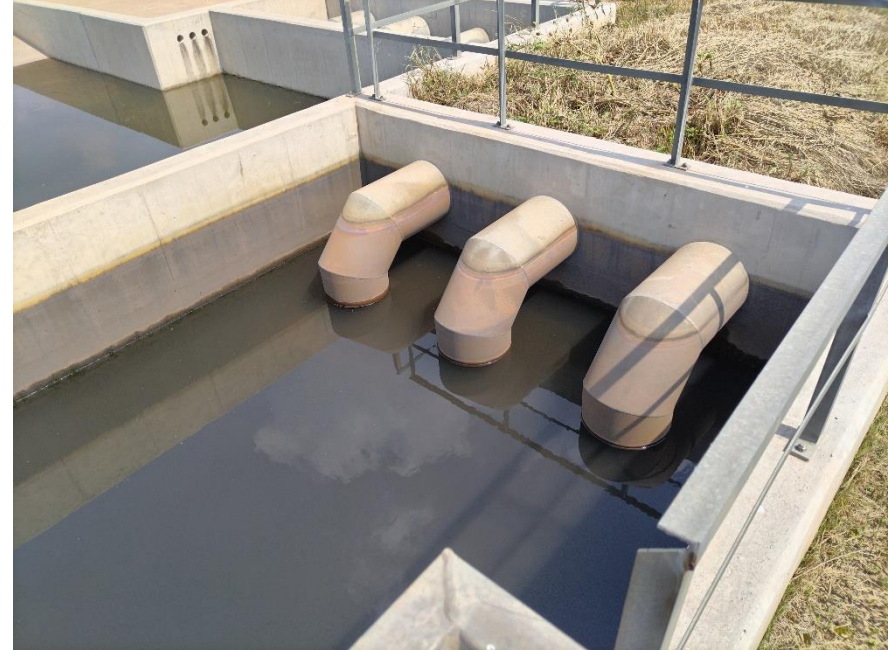
Photo 8: Inlet pipes

Satisfactory
No concerns

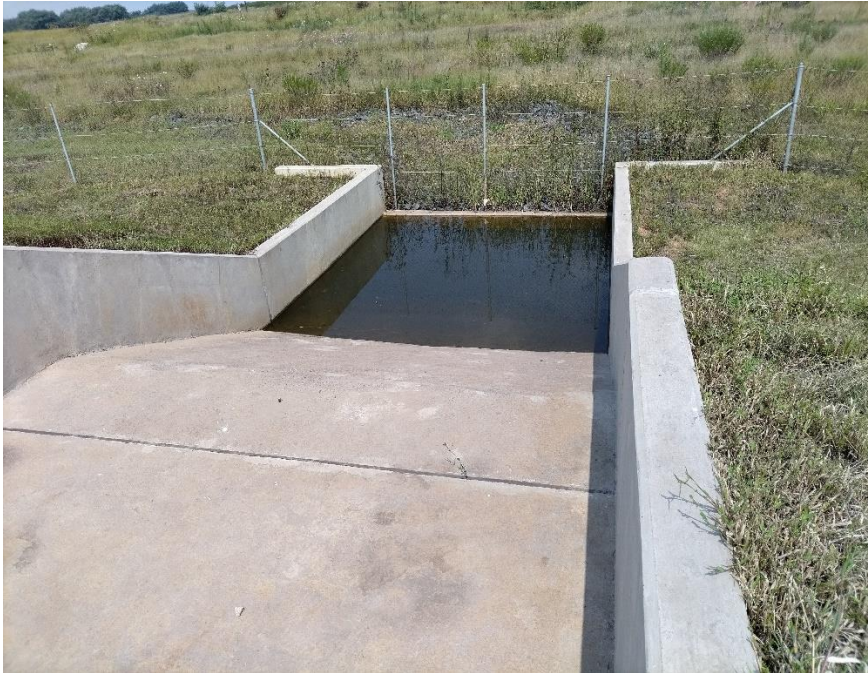
Photo 11: Outflow spillway

Satisfactory
No concerns

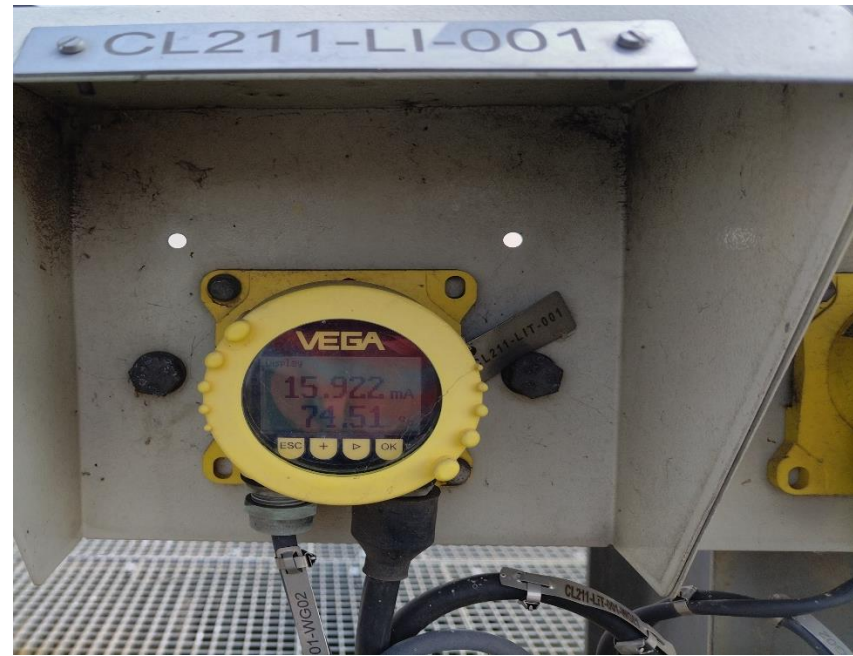
Photo 14: Flow monitor

Satisfactory
No concerns

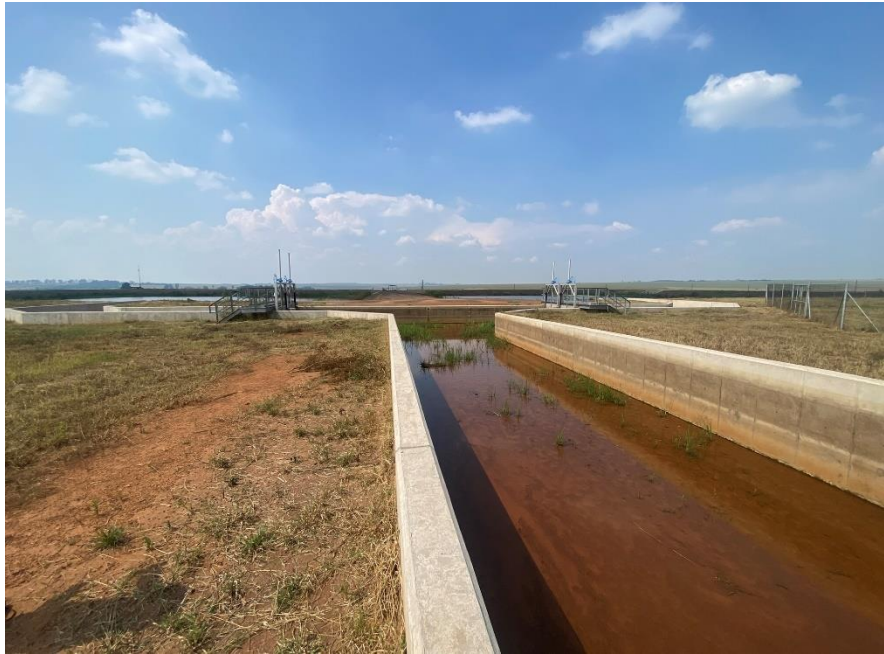
Photo 7: Inlet channel

Unsatisfactory

Silt accumulation inside the inlet channel leading to the silt trap

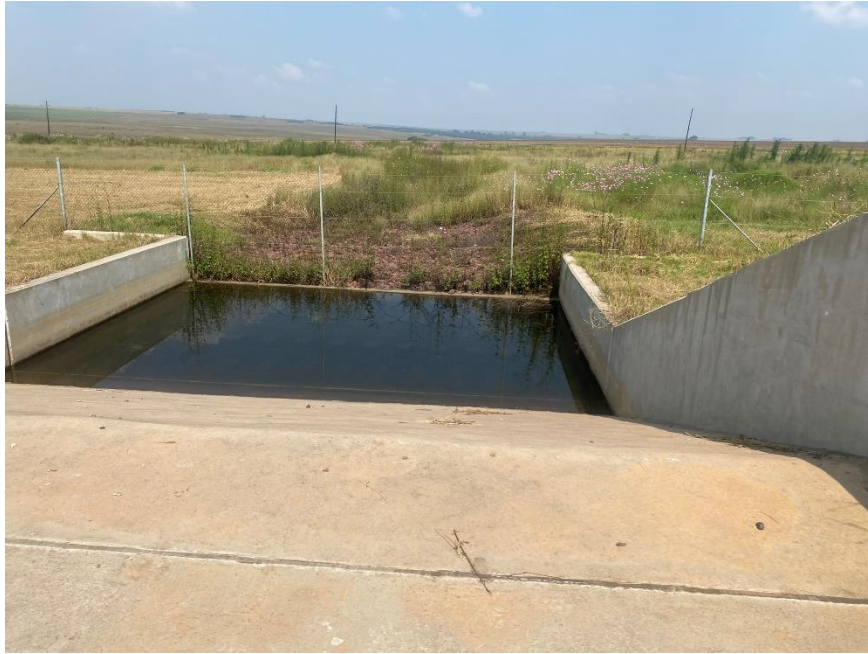
Photo 13: Overflow spillway

Unsatisfactory

Minor vegetation growth along the spillway

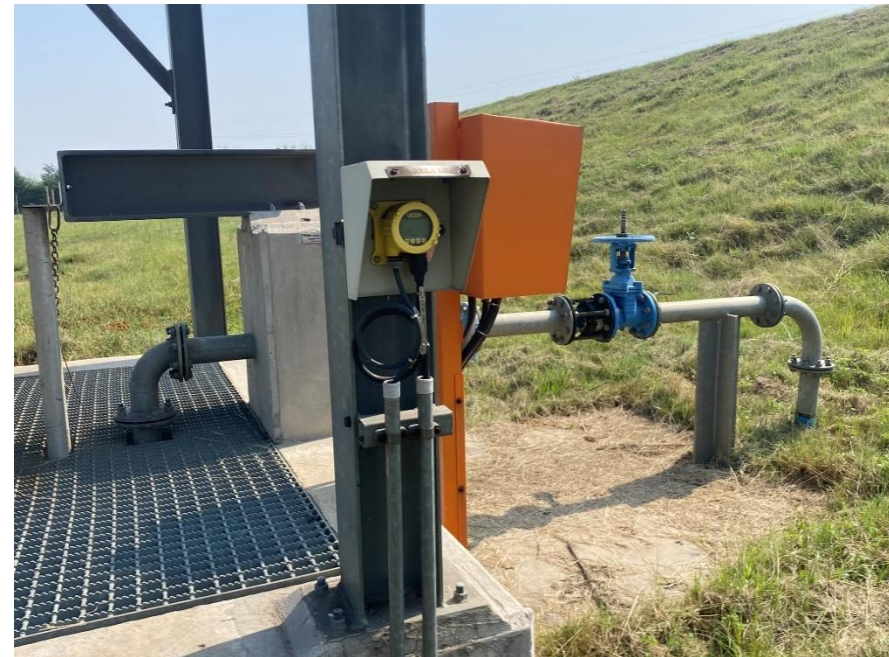
Photo 14: Flow monitor

Satisfactory
No concerns

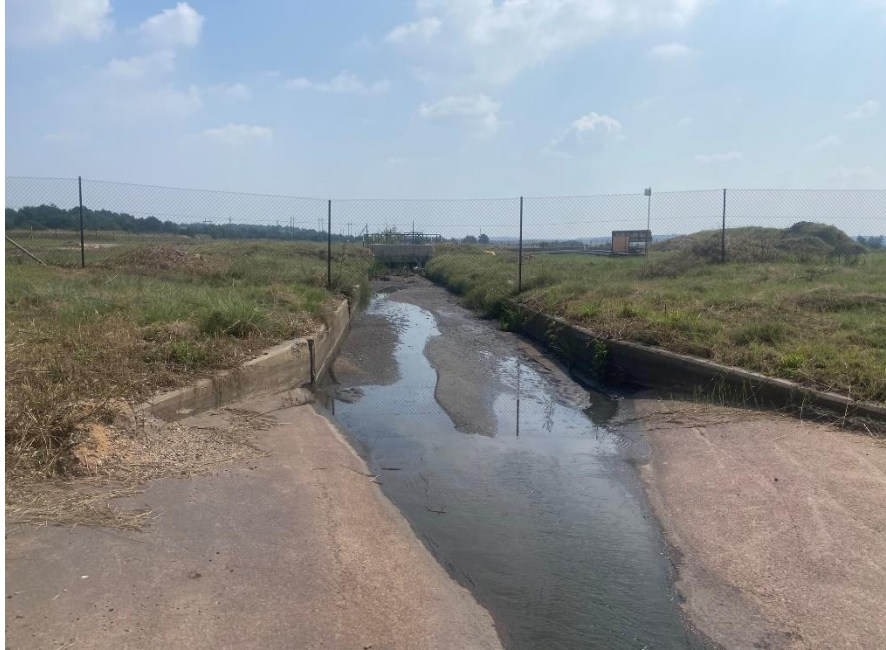
Photo 7: Inlet channel

Unsatisfactory

Silt accumulation inside the inlet channel leading to the silt trap

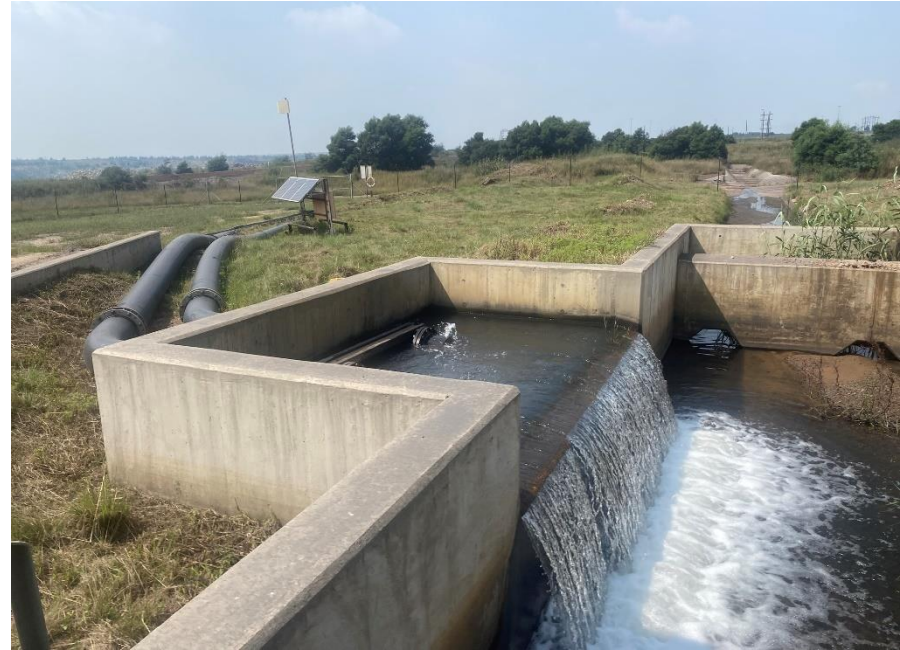
Photo 8: Inlet pipes

Note the two uPVC pipes discharging inside the silt trap

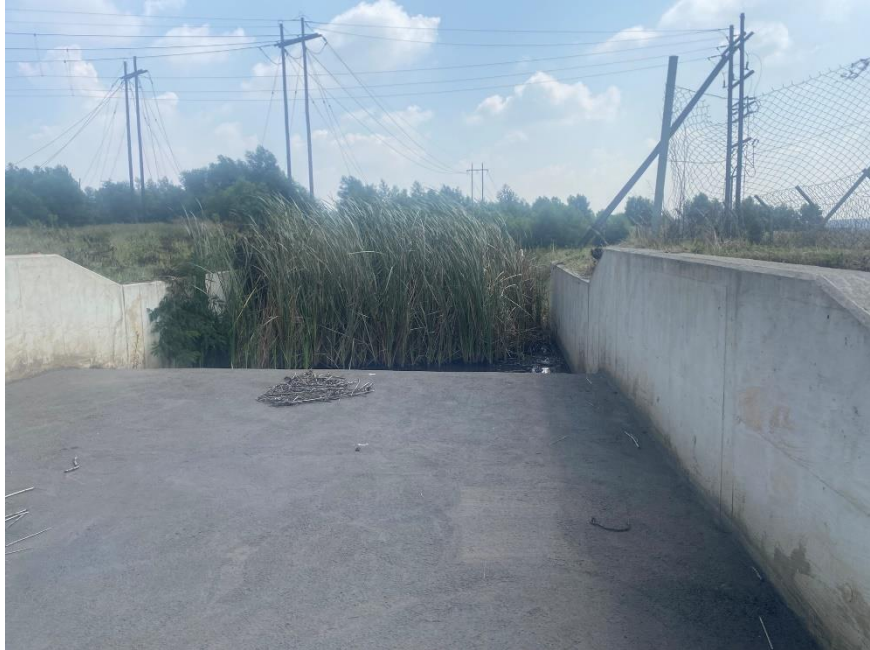
Photo 13: Overflow spillway

Unsatisfactory

Excessive reeds and vegetation growth along the spillway

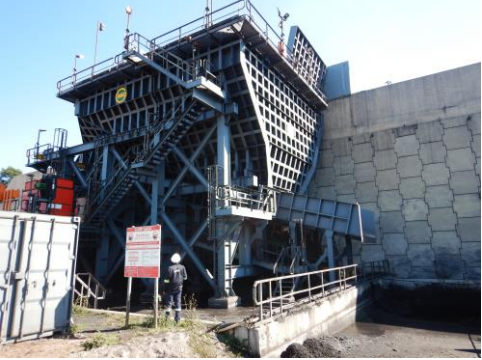
<p>Fig.1: Grizzly Feeder Structural Defect / Inspection Finding: The structure is in good condition. No evidence of any deterioration.</p> <table border="1" data-bbox="240 783 792 856"> <tr> <td>Condition Category:</td> <td>2</td> <td>Priority:</td> <td>2</td> </tr> <tr> <td>Recommendation:</td> <td>Risk Rating:</td> <td>14</td> <td></td> </tr> </table> <p>Regular condition inspections should be conducted to identify defects early.</p>	Condition Category:	2	Priority:	2	Recommendation:	Risk Rating:	14

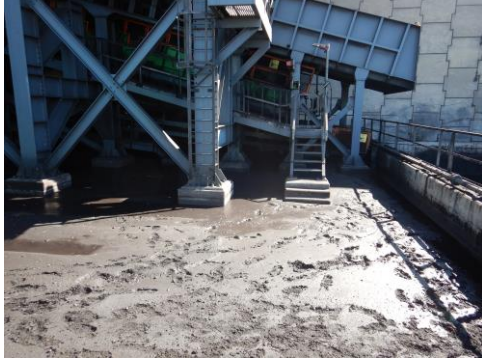
<p>Fig.2: Supports Structural Defect / Inspection Finding: Muddy water (mud) spilled on supports accelerate corrosion of steel and rebar.</p> <table border="1" data-bbox="824 783 1377 856"> <tr> <td>Condition Category:</td> <td>2</td> <td>Priority:</td> <td>2</td> </tr> <tr> <td>Recommendation:</td> <td>Risk Rating:</td> <td>9</td> <td></td> </tr> </table> <p>Clean spillage regularly to avoid corrosion of steel members and ingress of water into concrete supports.</p>	Condition Category:	2	Priority:	2	Recommendation:	Risk Rating:	9

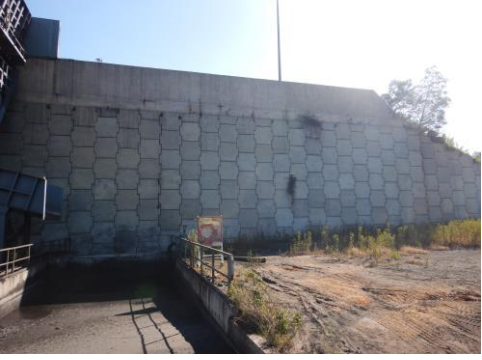
<p>Fig.3: Retaining Wall Structural Defect / Inspection Finding: The structure is in good condition. No evidence of any deterioration.</p> <table border="1" data-bbox="240 1497 792 1570"> <tr> <td>Condition Category:</td> <td>2</td> <td>Priority:</td> <td>2</td> </tr> <tr> <td>Recommendation:</td> <td>Risk Rating:</td> <td>14</td> <td></td> </tr> </table> <p>Regular condition inspections should be conducted to identify defects early.</p>	Condition Category:	2	Priority:	2	Recommendation:	Risk Rating:	14

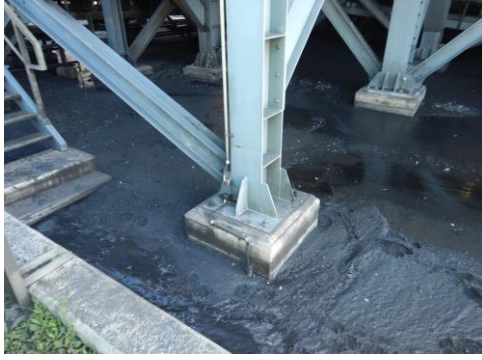
<p>Fig.4: Plinth Support Structural Defect / Inspection Finding: Muddy water (mud) spilled on supports accelerate corrosion of steel and rebar.</p> <table border="1" data-bbox="824 1497 1377 1570"> <tr> <td>Condition Category:</td> <td>2</td> <td>Priority:</td> <td>2</td> </tr> <tr> <td>Recommendation:</td> <td>Risk Rating:</td> <td>9</td> <td></td> </tr> </table> <p>Clean spillage regularly to avoid corrosion of steel members and ingress of water into concrete supports.</p>	Condition Category:	2	Priority:	2	Recommendation:	Risk Rating:	9

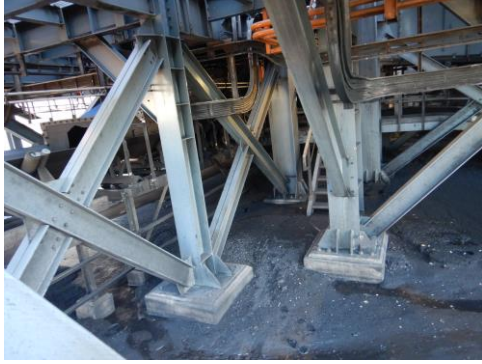
Fig.5: Support Plinth

Structural Defect / Inspection Finding:
Muddy water (mud) spilled on supports accelerate corrosion of steel and rebar.

Condition Category:	2	Priority:	2
Recommendation:	Risk Rating:	9	
Clean spillage regularly to avoid corrosion of steel members and ingress of water into concrete supports.

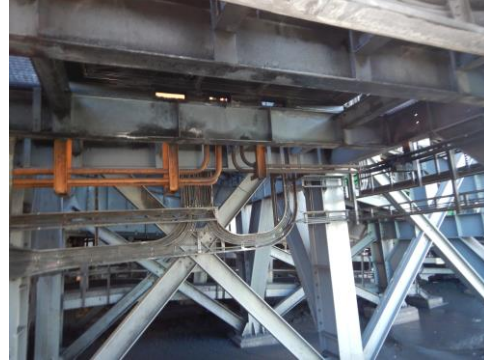
Fig.6: Support Beam

Structural Defect / Inspection Finding:
The structure is in good condition. No evidence of any deterioration.

Condition Category:	2	Priority:	2
Recommendation:	Risk Rating:	9	
Regular condition inspections should be conducted to identify defects early.

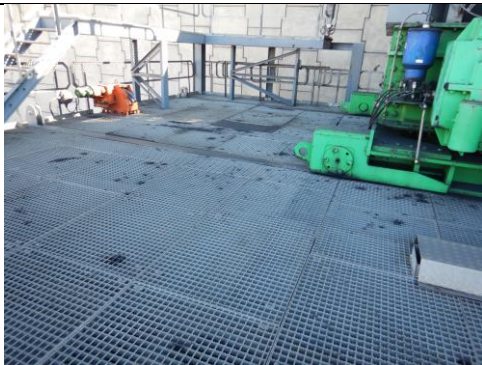
Fig.7: Grating

Structural Defect / Inspection Finding:
The structure is in good condition. No evidence of any deterioration.

Condition Category:	2	Priority:	2
Recommendation:	Risk Rating:	9	
Regular condition inspections should be conducted to identify defects early.

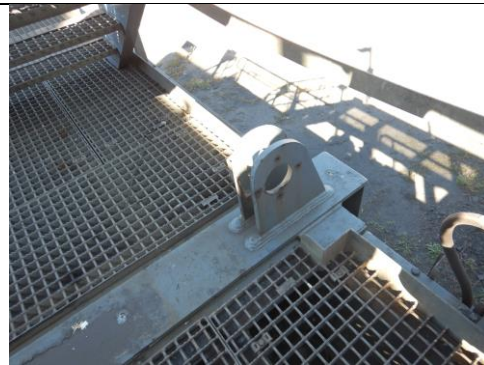
Fig.8: Anchor

Structural Defect / Inspection Finding:
The structure is in good condition. No evidence of any deterioration. But there's no Safe Working Load marked

Condition Category:	2	Priority:	2
Recommendation:	Risk Rating:	5	
Regular condition inspections should be conducted to identify defects early.

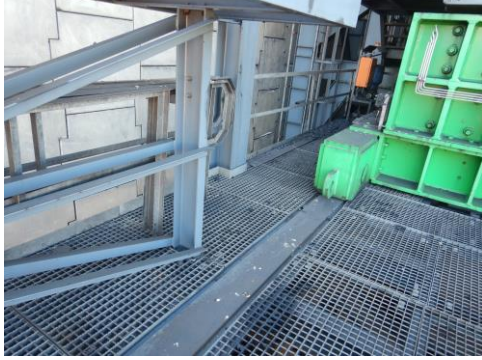
Fig.9: Grating

The structure is in good condition. No evidence of any deterioration.

Condition Category:	2	Priority:	2
Recommendation:	Risk Rating:		9

Regular condition inspections should be conducted to identify defects early.

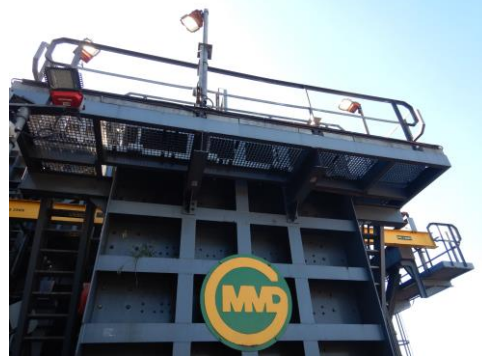
Fig.10: Grizzly Walls

The structure is in good condition. No evidence of any deterioration

Condition Category:	2	Priority:	2
Recommendation:	Risk Rating:		9

Regular condition inspections should be conducted to identify defects early.

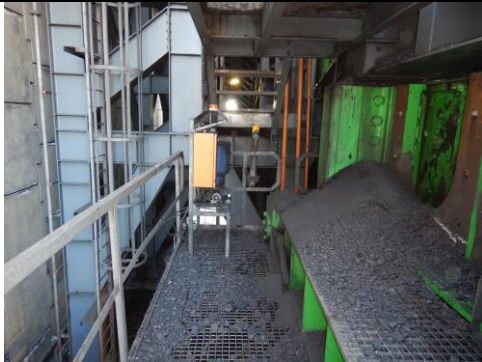
Fig.11: Walkway

Spillage on grating and corrosion protection is peeling off.

Condition Category:	2	Priority:	2
Recommendation:	Risk Rating:		9

Clear spillage regularly and prepare repaint exposed sections.

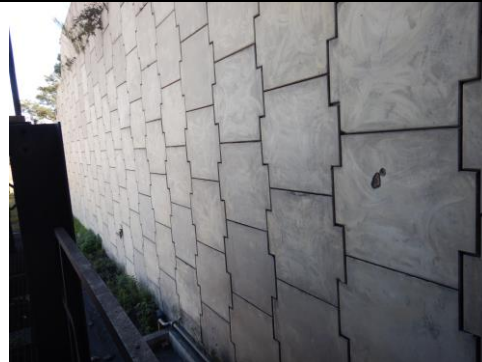
Fig.12: Retaining Wall

The structure is in good condition. No evidence of any deterioration.

Condition Category:	2	Priority:	2
Recommendation:	Risk Rating:		14

Regular condition inspections should be conducted to identify defects early.

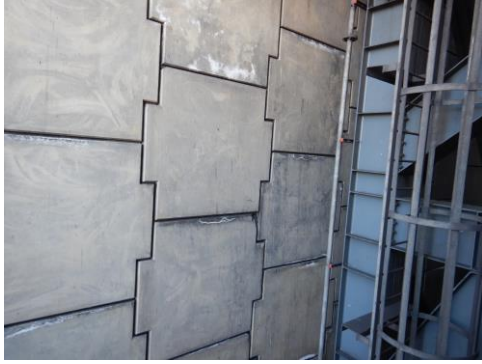
Fig.13: Retaining Wall

Structural Defect / Inspection Finding:
The structure is in good condition. No evidence of any deterioration.

Condition Category:	2	Priority:	2
Recommendation:		Risk Rating:	14

Regular condition inspections should be conducted to identify defects early.

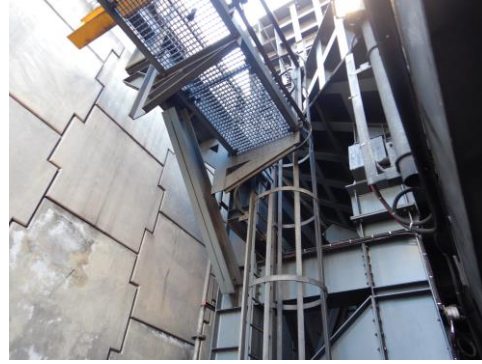
Fig.14: Walkway Support

Structural Defect / Inspection Finding:
The structure is in good condition. No evidence of any deterioration.

Condition Category:	2	Priority:	2
Recommendation:		Risk Rating:	9

Regular condition inspections should be conducted to identify defects early.

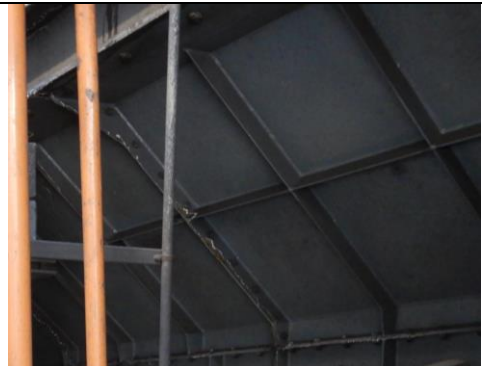
Fig.15: Chute Wall

Structural Defect / Inspection Finding:
The structure is in good condition. No evidence of any deterioration.

Condition Category:	2	Priority:	2
Recommendation:		Risk Rating:	9

Regular condition inspections should be conducted to identify defects early.

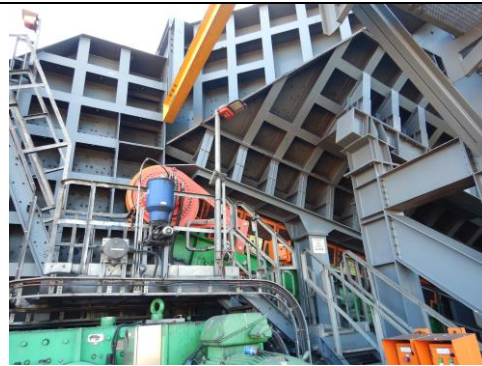
Fig.16: General

Structural Defect / Inspection Finding:
The structure is in good condition. No evidence of any deterioration.

Condition Category:	2	Priority:	2
Recommendation:		Risk Rating:	9

Regular condition inspections should be conducted to identify defects early.

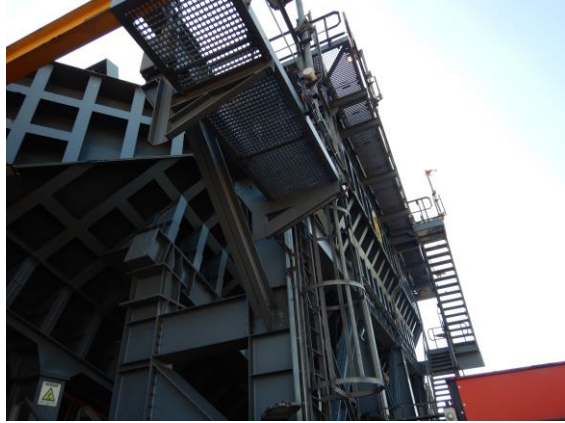
Fig.17: Walkway Support

The structure is in good condition. No evidence of any deterioration.

Condition Category:	2	Priority:	2
Recommendation:		Risk Rating:	9

Regular condition inspections should be conducted to identify defects early.

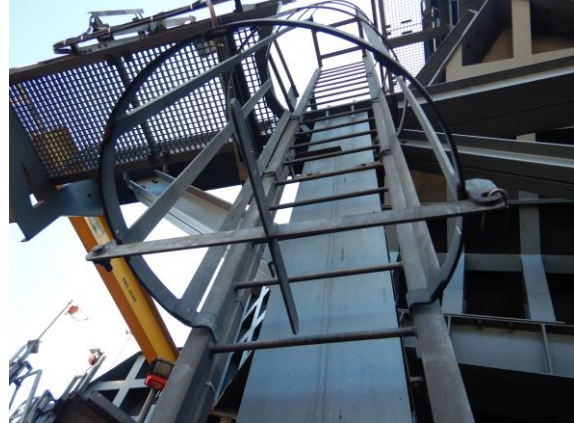
Fig.18: Access ladder

The structure is in good condition. No evidence of any deterioration.

Condition Category:	2	Priority:	2
Recommendation:		Risk Rating:	3

Regular condition inspections should be conducted to identify defects early.

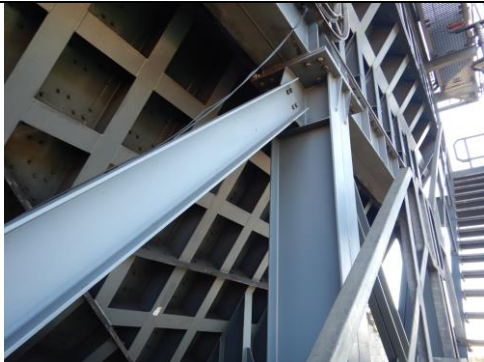
Fig.19: Connection

The structure is in good condition. No evidence of any deterioration.

Condition Category:	2	Priority:	2
Recommendation:		Risk Rating:	9

Regular condition inspections should be conducted to identify defects early.

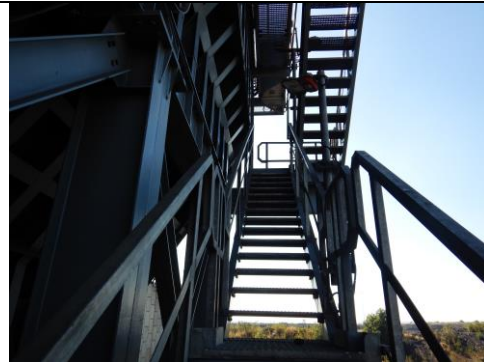
Fig.20: Staircase

The structure is in good condition. No evidence of any deterioration.

Condition Category:	2	Priority:	2
Recommendation:		Risk Rating:	9

Regular condition inspections should be conducted to identify defects early.

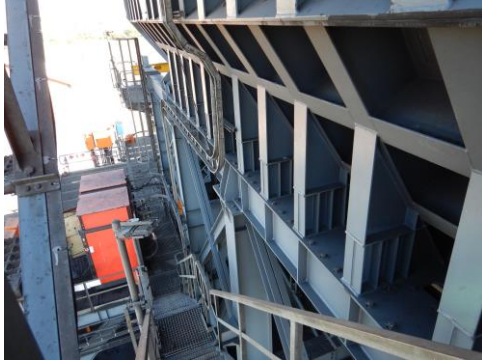
Fig.21: Grizzly Wall

Structural Defect / Inspection Finding:
The structure is in good condition. No evidence of any deterioration.

Condition Category:	2	Priority:	2
Recommendation:	Risk Rating:		9

Regular condition inspections should be conducted to identify defects early.

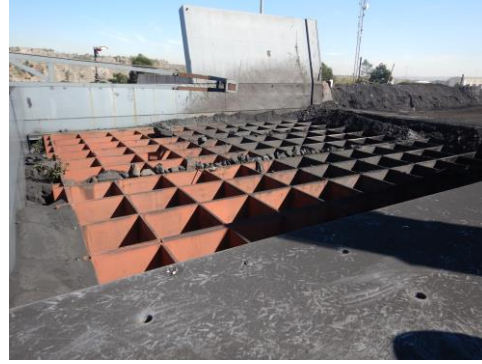
Fig.22: Grizzly Grillage

Structural Defect / Inspection Finding:
The structure is in good condition. No evidence of any deterioration.

Condition Category:	2	Priority:	2
Recommendation:	Risk Rating:		9

Regular condition inspections should be conducted to identify defects early.

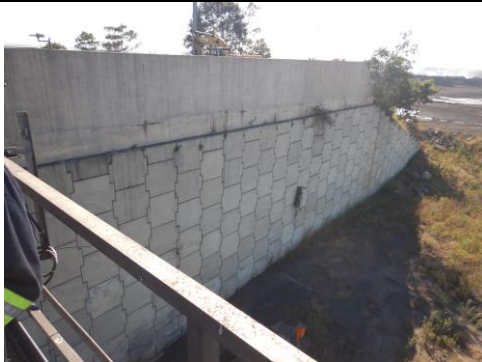
Fig.23: Retaining Wall

Structural Defect / Inspection Finding:
The structure is in good condition. No evidence of any deterioration.

Condition Category:	2	Priority:	2
Recommendation:	Risk Rating:		14

Regular condition inspections should be conducted to identify defects early.

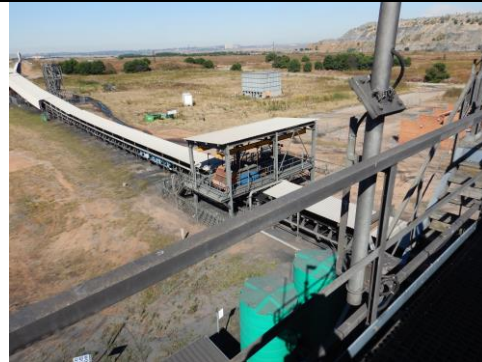
Fig.24: General

Structural Defect / Inspection Finding:
The structure is in good condition. No evidence of any deterioration.

Condition Category:	2	Priority:	2
Recommendation:	Risk Rating:		9

Regular condition inspections should be conducted to identify defects early.

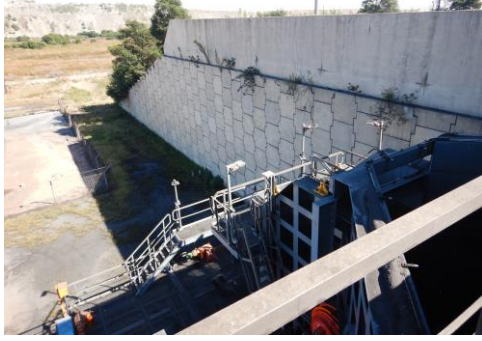
Fig.25: Retaining Wall

Structural Defect / Inspection Finding:
The structure is in good condition. No evidence of any deterioration.

Condition Category:	2	Priority:	2
Recommendation:	Risk Rating:	14

Regular condition inspections should be conducted to identify defects early.

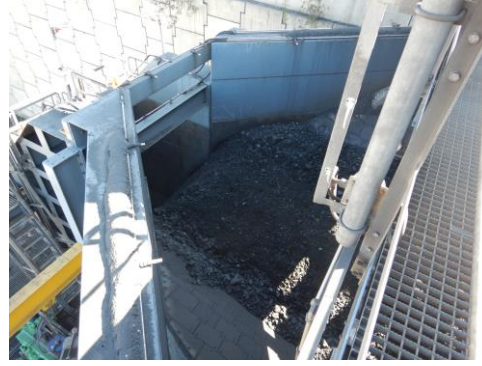
Fig.26: Apron Feeder

Structural Defect / Inspection Finding:
The structure is in good condition. No evidence of any deterioration.

Condition Category:	2	Priority:	2
Recommendation:	Risk Rating:	9

Regular condition inspections should be conducted to identify defects early.

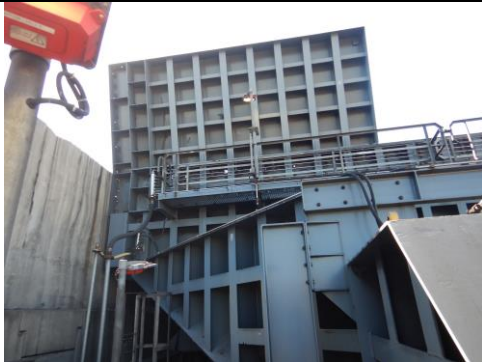
Fig.27: Grizzly Walls

Structural Defect / Inspection Finding:
The structure is in good condition. No evidence of any deterioration.

Condition Category:	2	Priority:	2
Recommendation:	Risk Rating:	9

Regular condition inspections should be conducted to identify defects early.

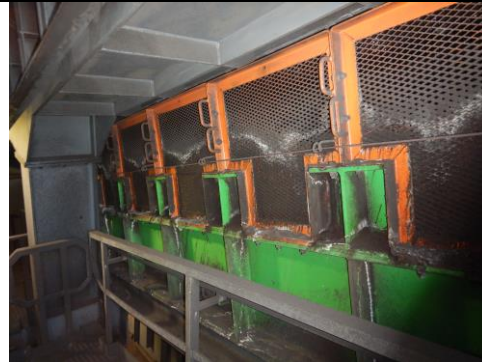
Fig.28: Support Beam

Structural Defect / Inspection Finding:
The structure is in good condition. No evidence of any deterioration.

Condition Category:	2	Priority:	2
Recommendation:	Risk Rating:	9

Regular condition inspections should be conducted to identify defects early.

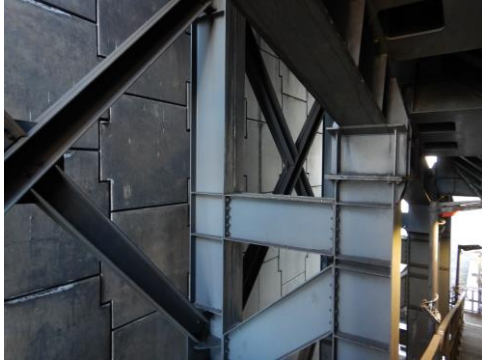
Fig.29: Support members

Structural Defect / Inspection Finding:
The structure is in good condition. No evidence of any deterioration.

Condition Category:	2	Priority:	2
Recommendation:		Risk Rating:	9

Regular condition inspections should be conducted to identify defects early.

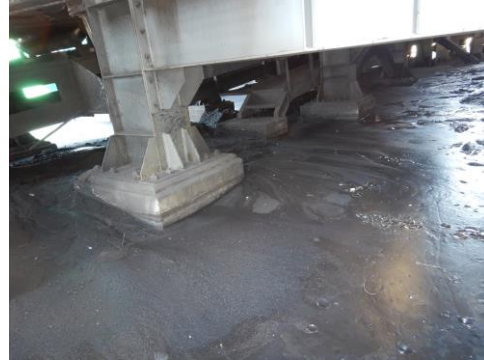
Fig.30: Plinth Support

Structural Defect / Inspection Finding:
Muddy water (mud) spilled on supports accelerate corrosion of steel and rebar.

Condition Category:	2	Priority:	2
Recommendation:		Risk Rating:	9

Clean spillage regularly to avoid corrosion of steel members and ingress of water into concrete supports.

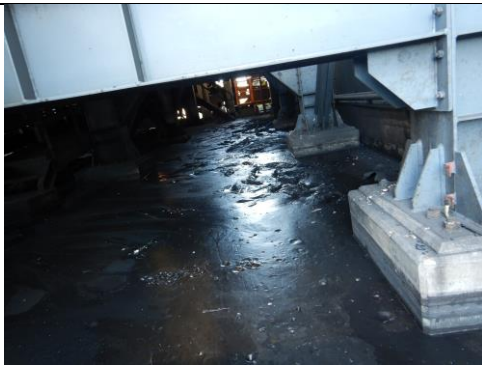
Fig.31: Plinth Supports

Structural Defect / Inspection Finding:
Muddy water (mud) spilled on supports accelerate corrosion of steel and rebar.

Condition Category:	2	Priority:	2
Recommendation:		Risk Rating:	9

Clean spillage regularly to avoid corrosion of steel members and ingress of water into concrete supports.

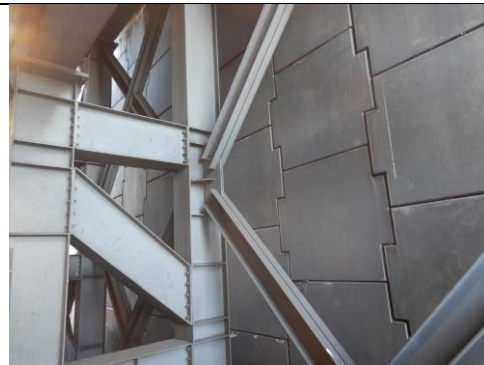
Fig.32: Support members

Structural Defect / Inspection Finding:
The structure is in good condition. No evidence of any deterioration.

Condition Category:	2	Priority:	2
Recommendation:		Risk Rating:	9

Regular condition inspections should be conducted to identify defects early.

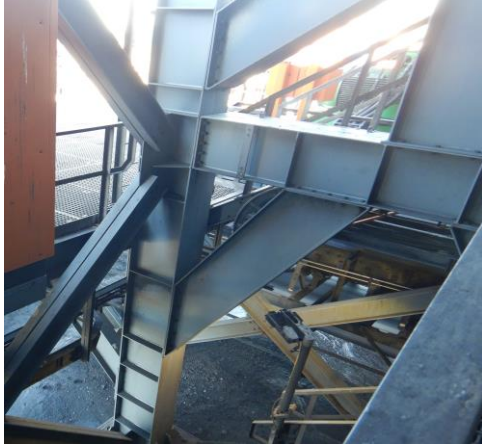
Fig.33: Support members

The structure is in good condition. No evidence of any deterioration.

Condition Category:	2	Priority:	2
Recommendation:		Risk Rating:	9

Regular condition inspections should be conducted to identify defects early.
